May 20, 2020

Subject: 2020 Visual Stream Assessment (VSA)
MS4 Permit – Non-Analytical Stream Monitoring
City of Spring Hill, Maury and Williamson Counties, Tennessee
CEC Project 194-523.0001

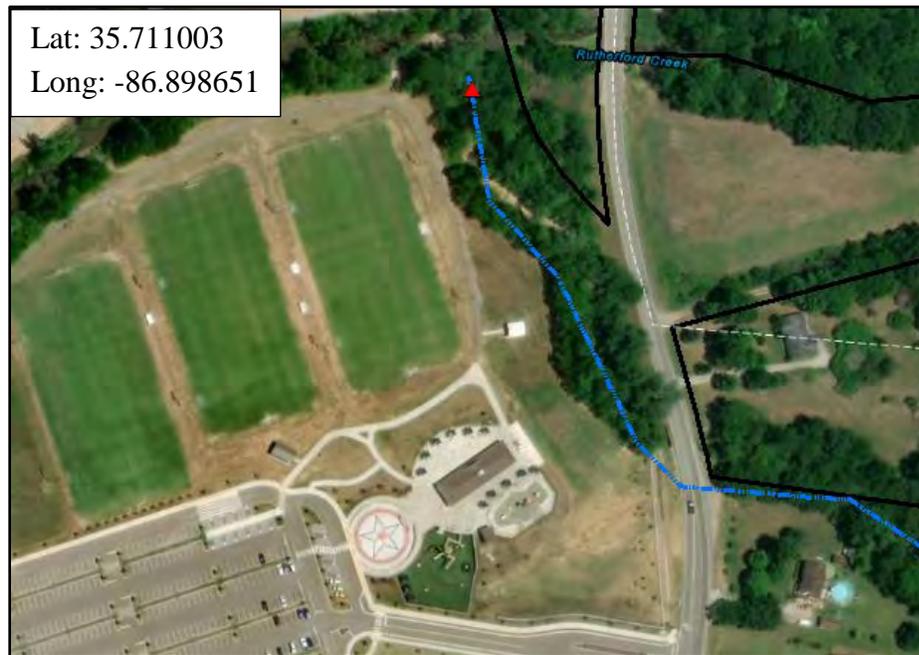
During the stream survey, CEC personnel observed streambank erosion near Port Royal Park. The bank erosion is approximately 300 Linear Feet (LF) with an average exposed bank height of 10 feet. A change in the surrounding land use is likely a contributor to the streambank erosion. This point is listed as an “Erosion Site” point (Object ID 9) in the geodatabase provided. Refer to Figure 1.

*Photo 1 - Aerial View of Erosion Site
(Red Triangle Indicates Erosion Site Location)*

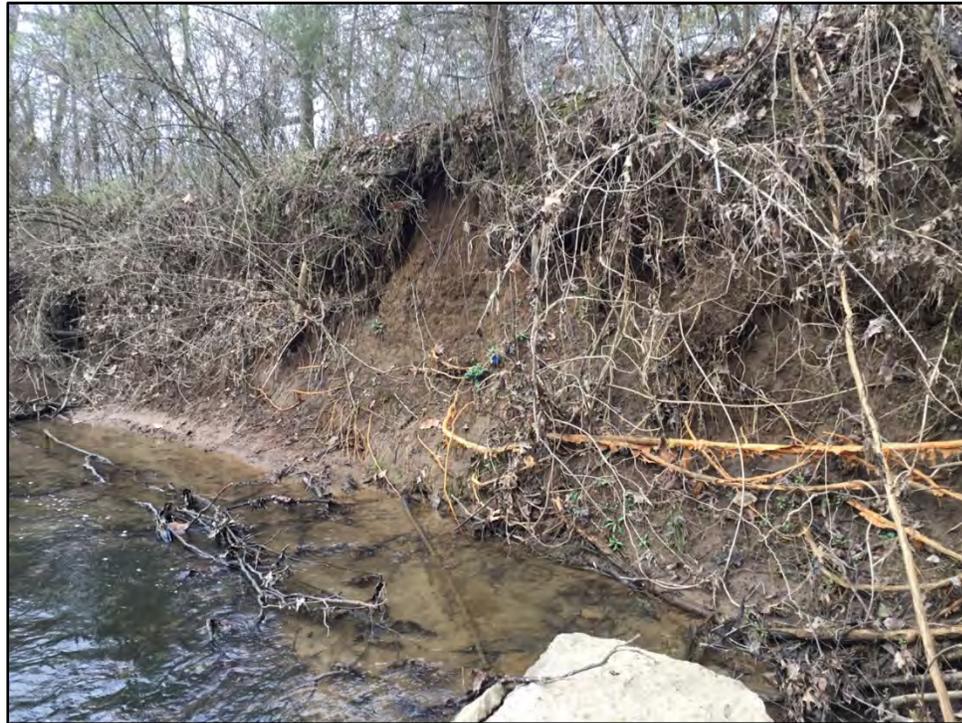
Photo 2 - View of Streambank Erosion (Object ID 9)

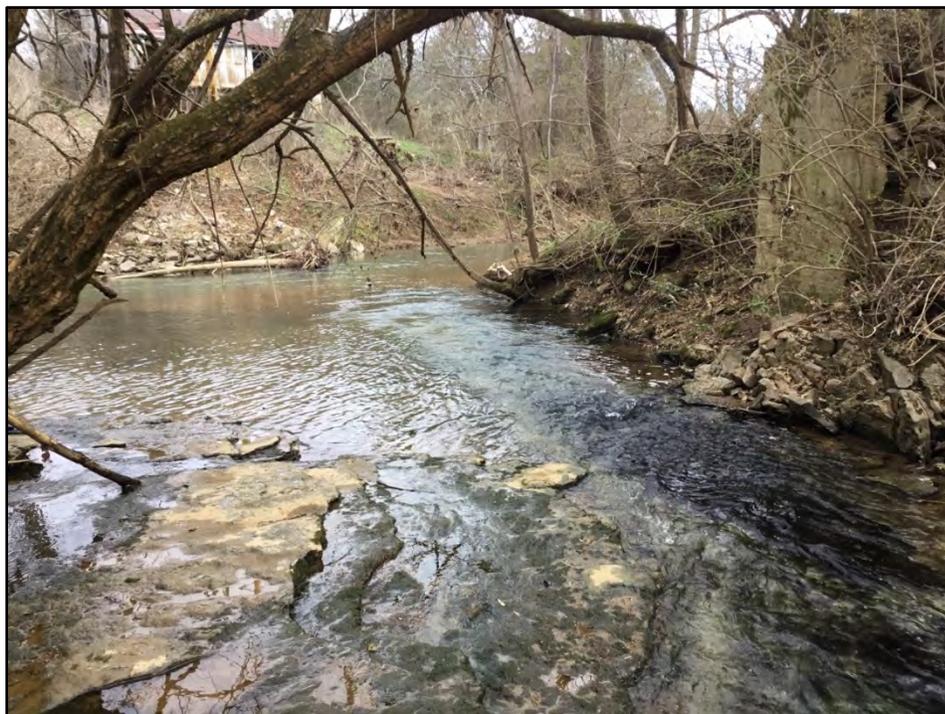
Photo 3 - View of Streambank Erosion near the Confluence of Crooked and Rutherford Creeks

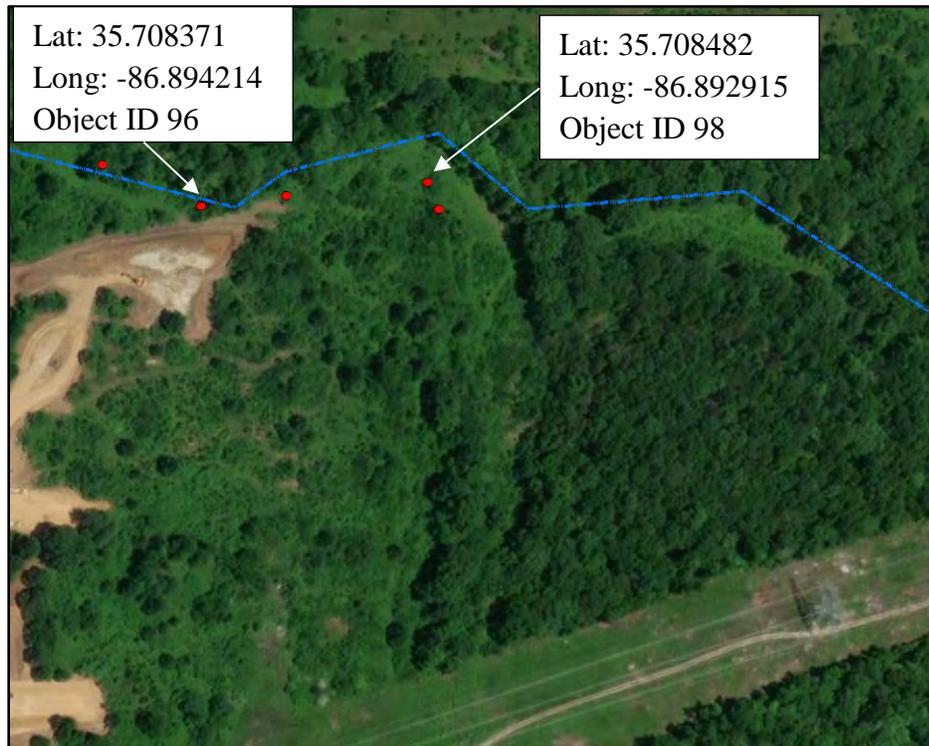
Multiple pipe outfalls were noted discharging directly into Crooked Creek. Two pipe outfalls were of particular concern due to the amount of sedimentation that was observed in and around the outfalls. TDEC lists Crooked Creek as a water with unavailable parameters due to sedimentation and siltation as well as habitat alteration. CEC recommends that the City inspect these outfall locations for potential maintenance. These points are listed as “Pipe Outfall” points (Object ID 96 and 98) in the geodatabase provided. Refer to Figure 1.

*Photo 4 - Aerial View of Pipe Outfalls
(Red Dots Indicate Outfall Locations)*

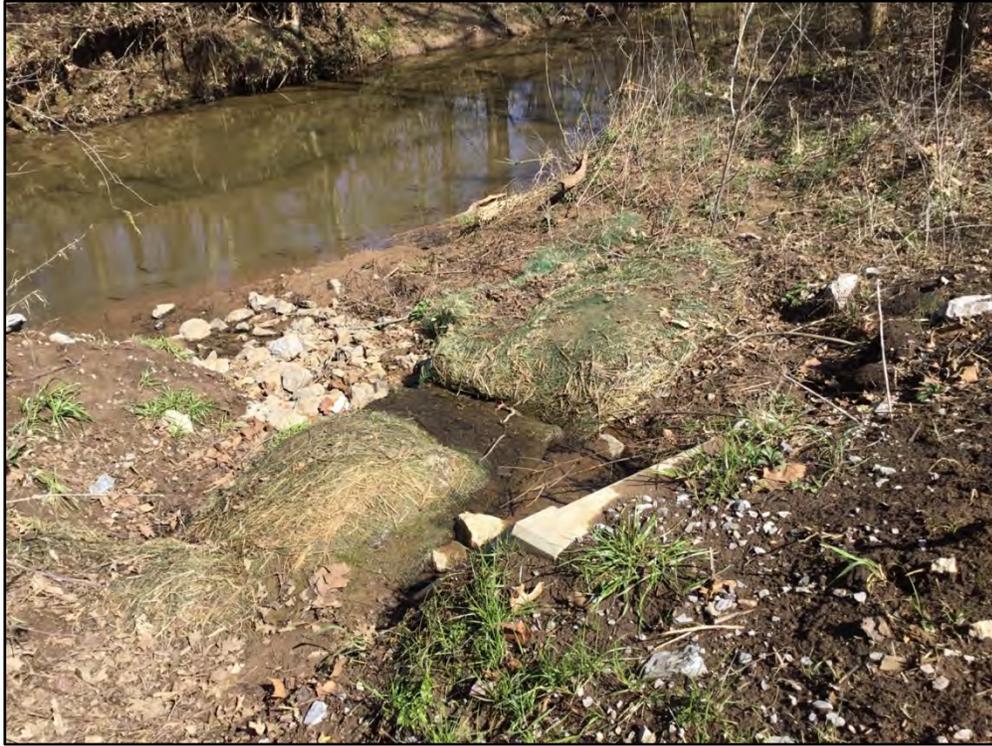
Photo 5 - View of Sedimentation at Pipe Outfall (Object ID 96)

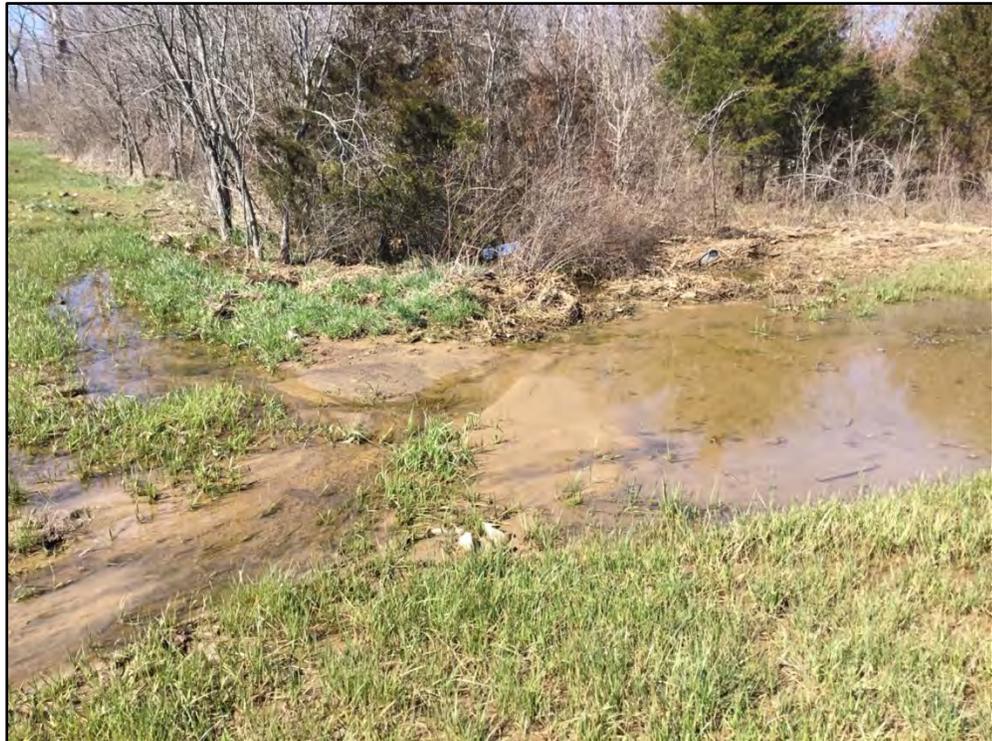
Photo 6 - View of Sedimentation at Pipe Outfall (Object ID 98)

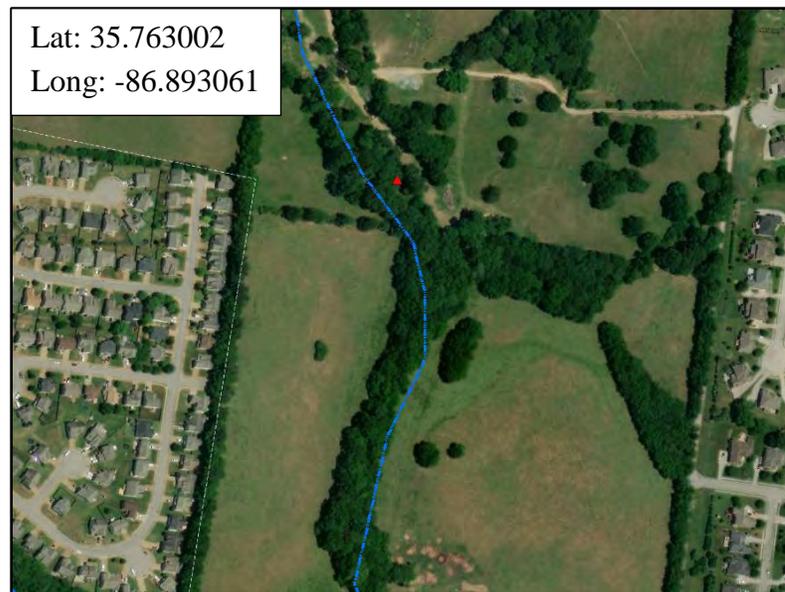
Streambank erosion was noted south of Brixworth Drive. The erosion was occurring behind a wing wall and encroaching near a sidewalk. CEC recommends that the City inspect the site for potential threat to infrastructure. This point is an “Erosion Site” point (Object ID 28) in the geodatabase provided. Refer to Figure 2.

*Photo 7 - Aerial View of Erosion Site
(Red Triangle Indicates Erosion Site Location)*

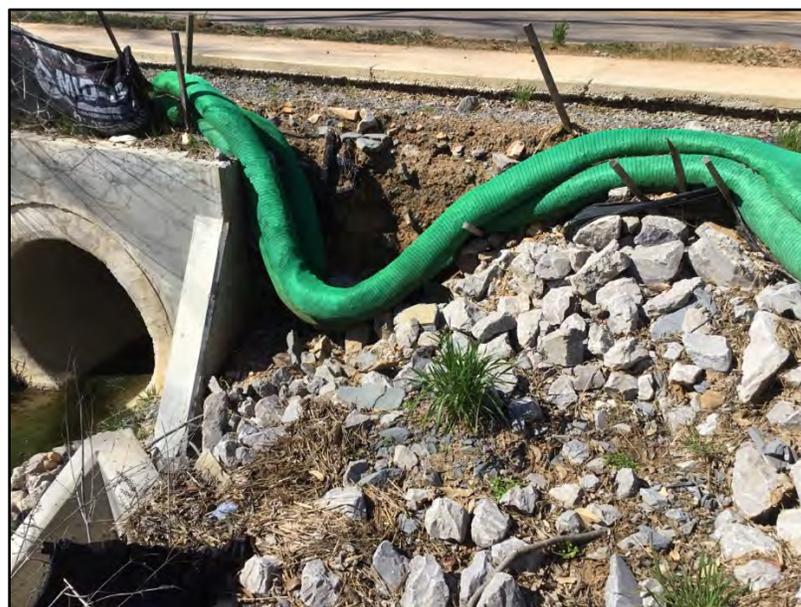
Photo 8 - View of Erosion Site (Object ID 28)

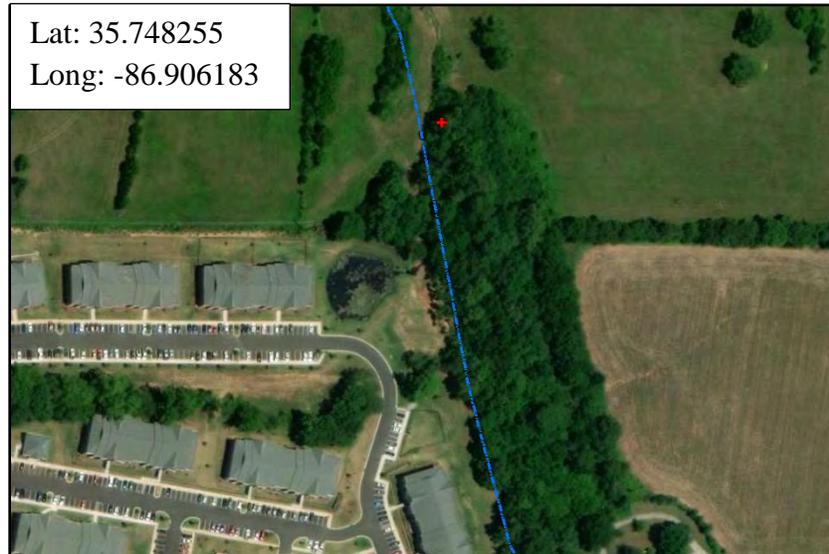
A debris dam was noted as blocking a box culvert thereby creating a fish barrier. CEC recommends that the City inspect this site for maintenance. This point is a “Fish Barrier” point (Object ID 7) in the geodatabase provided. Refer to Figure 2.

*Photo 9 - Aerial View of Fish Barrier
(Red Cross Indicates Fish Barrier Location)*

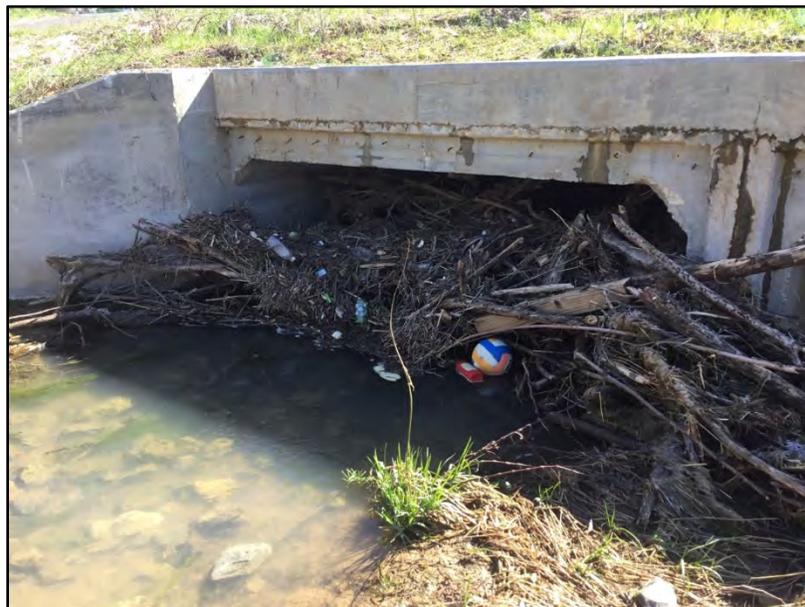
Photo 10 - View of Fish Barrier (Object ID 7)

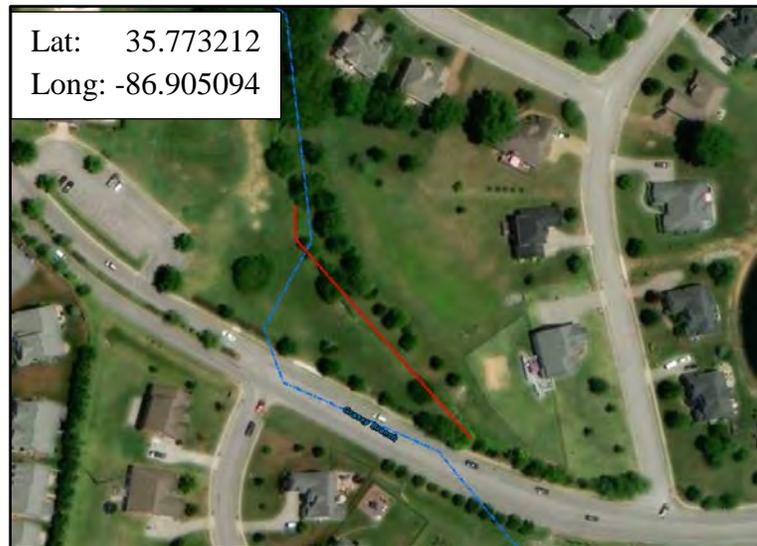
Approximately 368 LF of stream was observed to have little or no riparian buffer. Adequate riparian buffers provide a reduction in the amount of sediment, nutrients and other contaminants that enter surface waters. Riparian buffers also provide stream shading which is important to sensitive benthic invertebrates that require cooler water temperatures. This point is an “Inadequate Buffer” point (Object ID 4) in the geodatabase provided. Refer to Figure 2.

*Photo 11 - Aerial View of Inadequate Buffer
(Red Line Indicates Inadequate Buffer Location)*

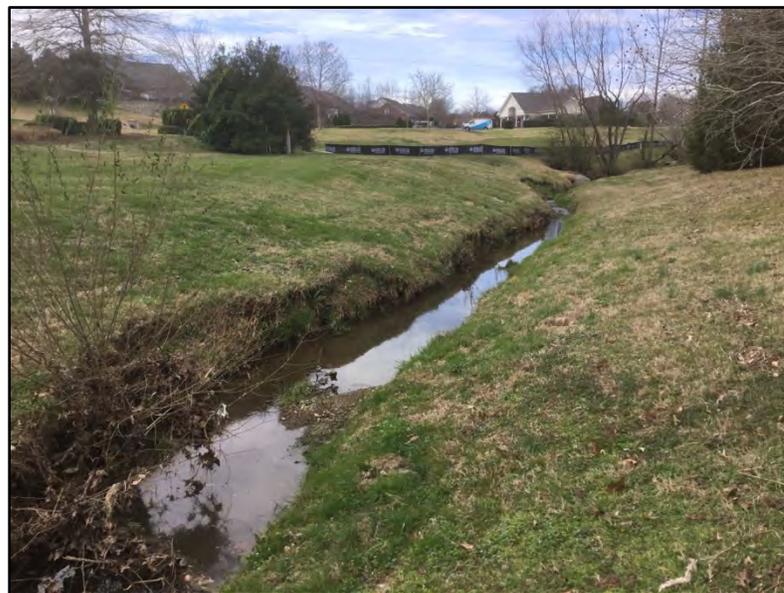
Photo 12 - View of Inadequate Buffer (Object ID 4)

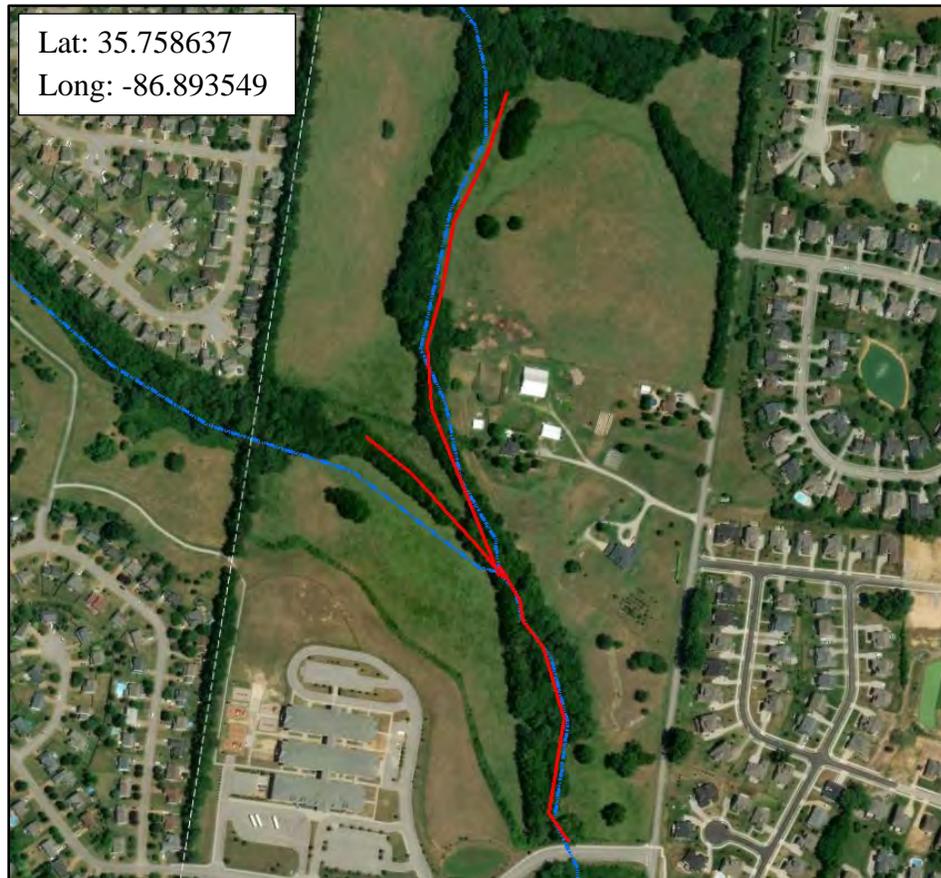
CEC field personnel noted inadequate buffers near Savannah Park Drive. Approximately 3,156 LF of streambank exhibited little to no riparian buffer. Many areas appeared to allow cattle to access the stream. CEC wants to bring the locations to the attention of the City due to the loss of habitat. These points are “Inadequate Buffer” points (Object IDs 1, 38 and 39) in the geodatabase provided. Refer to Figure 2.

*Photo 13 - Aerial View of Inadequate Buffers
(Red Lines Indicate Inadequate Buffer Locations)*

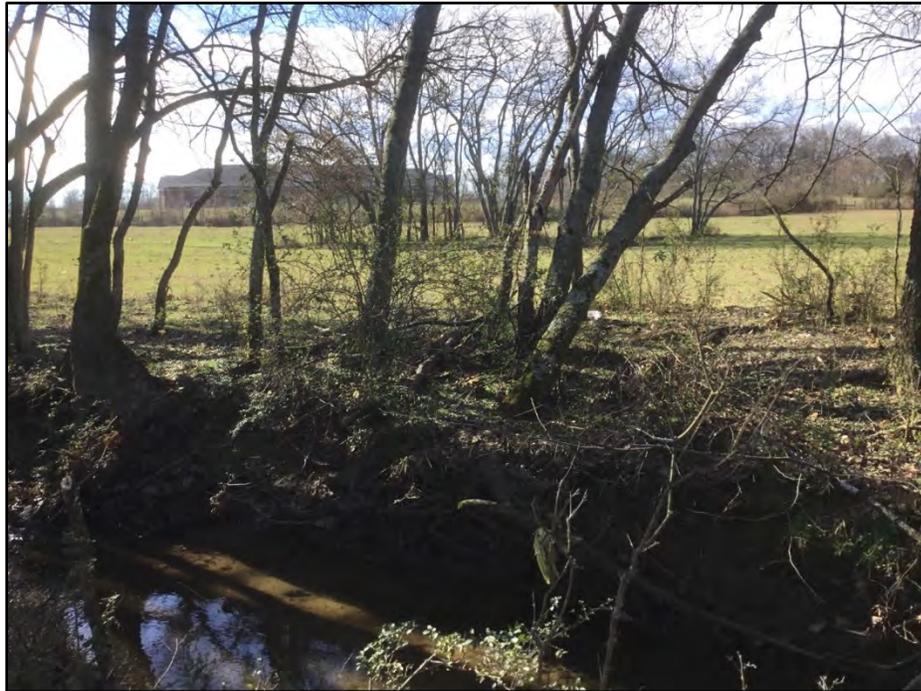
Photo 14 - View of the Inadequate Buffer

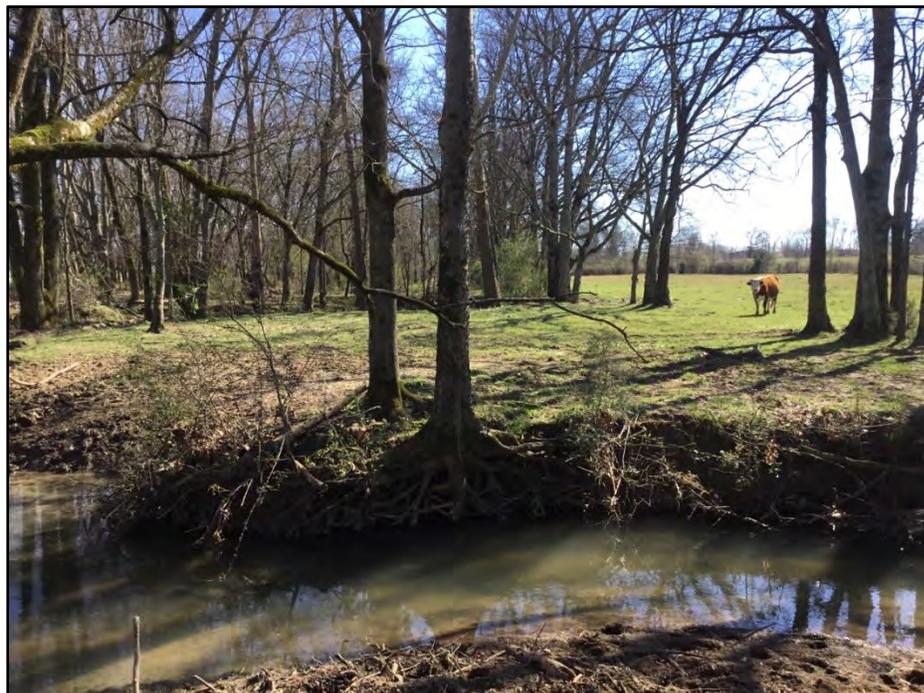
Photo 15 - View of the Inadequate Buffer

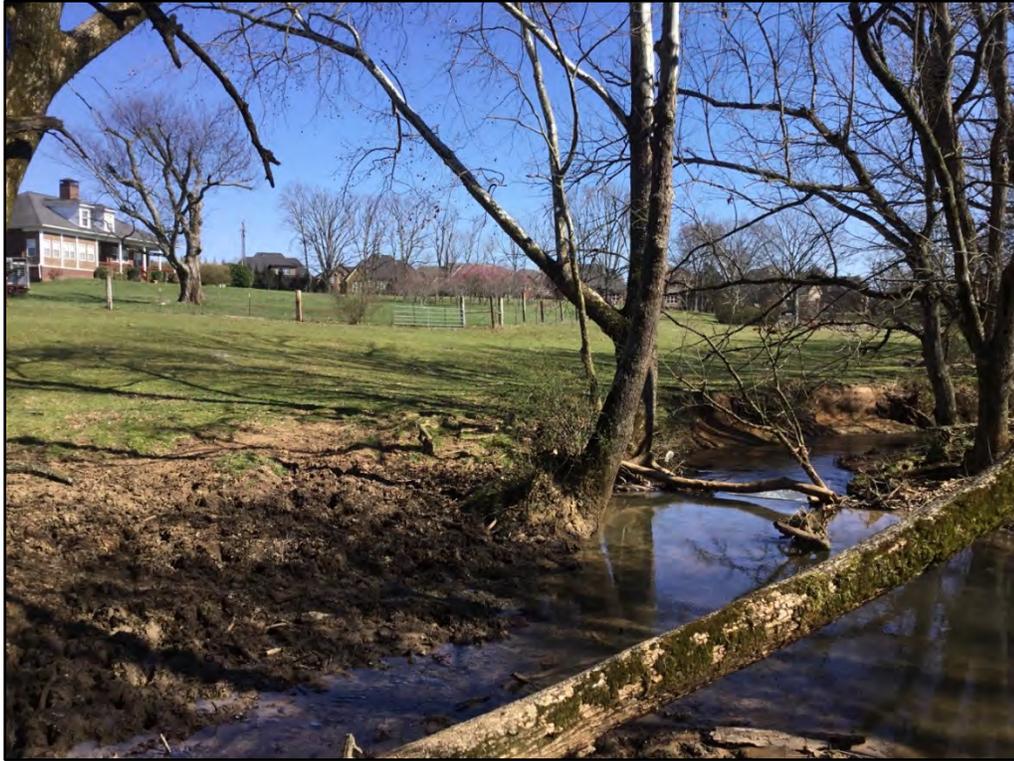
Photo 16 - View of the Inadequate Buffer where cattle access the stream

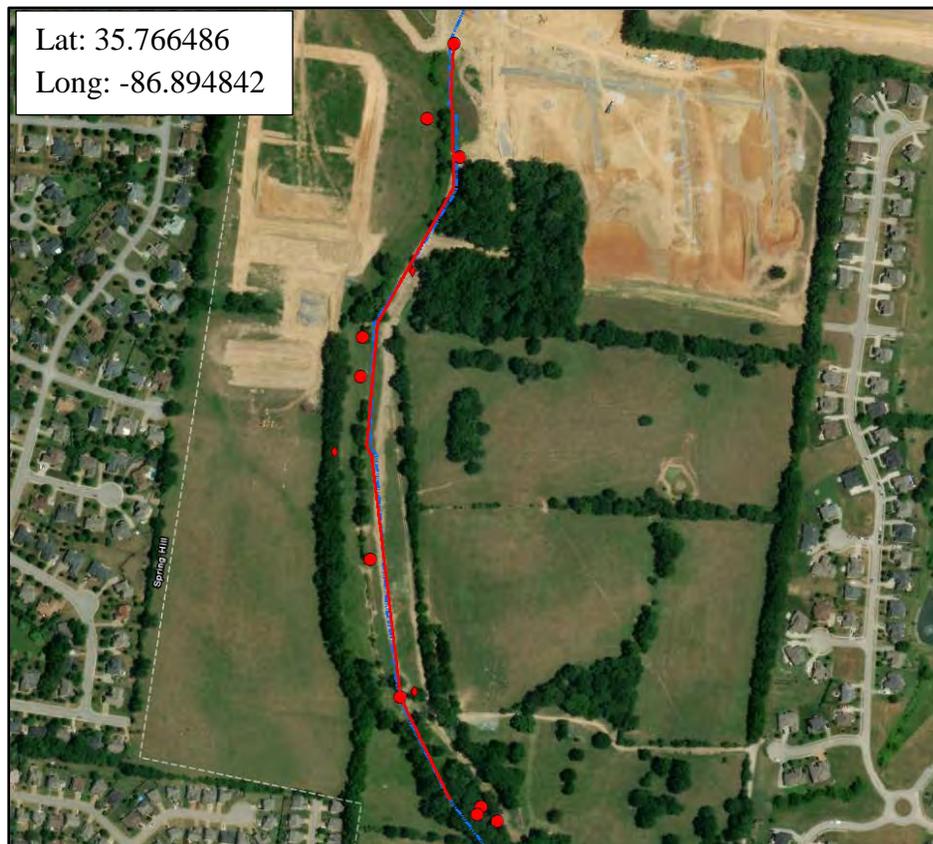
Near stream construction sites were present on both sides of the stream with multiple areas of concern. Some construction sites were observed to have inadequately maintained erosion control measures, and an inadequate buffer of approximately 2,843 LF was noted. An email was sent to the City on March 6, 2020, the same day that these points were collected, to expedite attention to the matter. These points are referenced as an “Inadequate Buffer” point (Object ID 37), “Pipe Outfall” point (Object IDs 127 and 131) and “In/Near Stream Construction” (Object ID 12, 13 and 14) point in the geodatabase provided. Refer to Figure 2.

*Photo 17 - Aerial View of the Near Stream Construction
(Red Line Indicates Inadequate Buffer Location, Red Dots Indicate Pipe Outfall
Locations, and Red Diamonds Indicate Near Stream Construction Locations)*

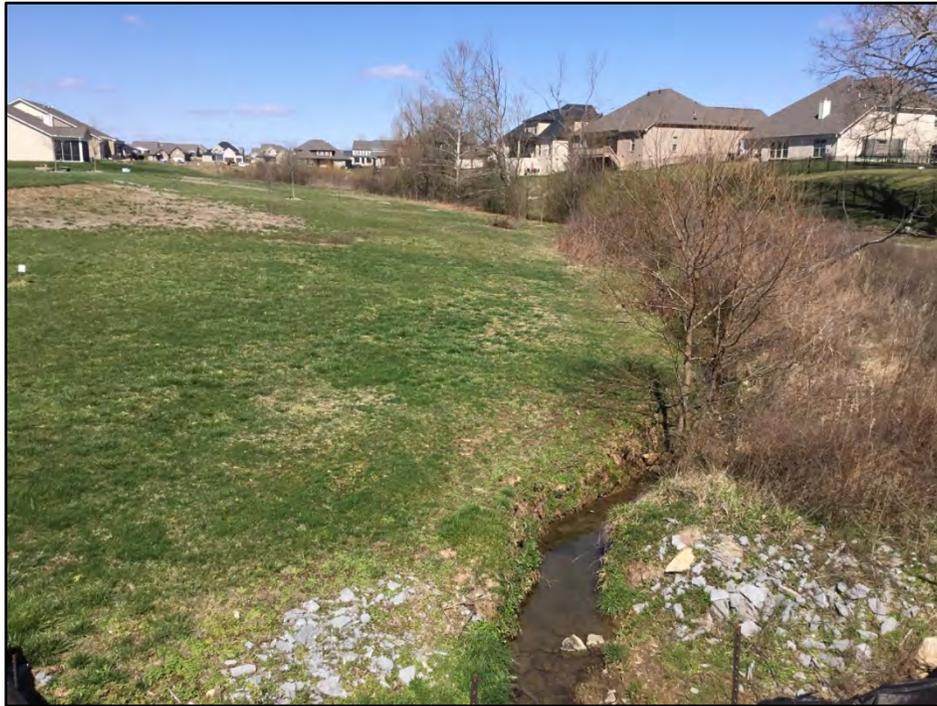
Photo 18 - View of the Inadequate Buffer (Object ID 37)

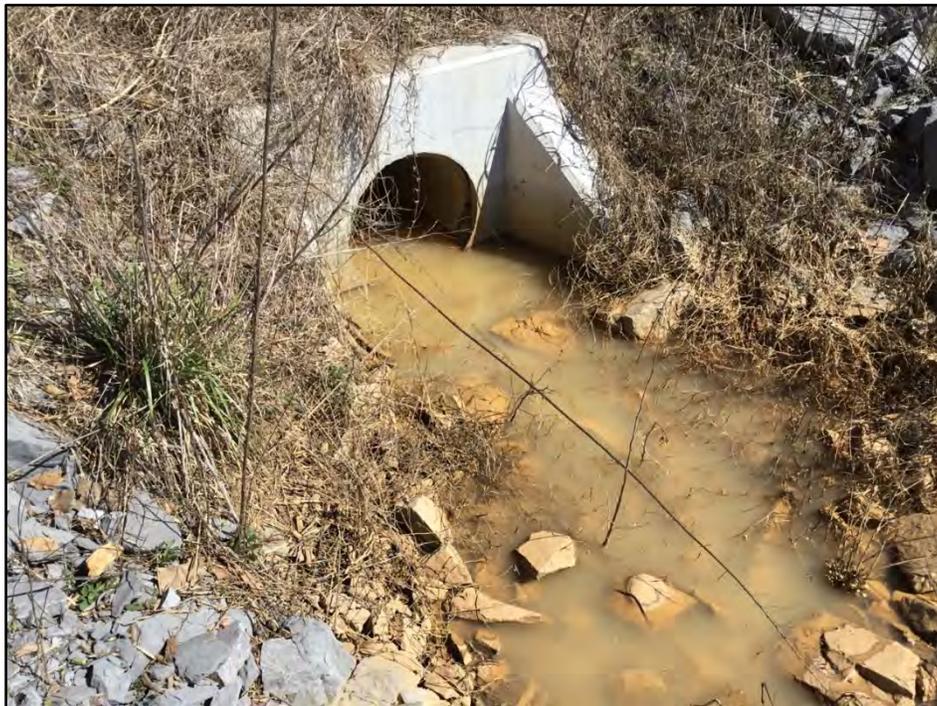
Photo 19 - View of Sedimentation at a Pipe Outfall

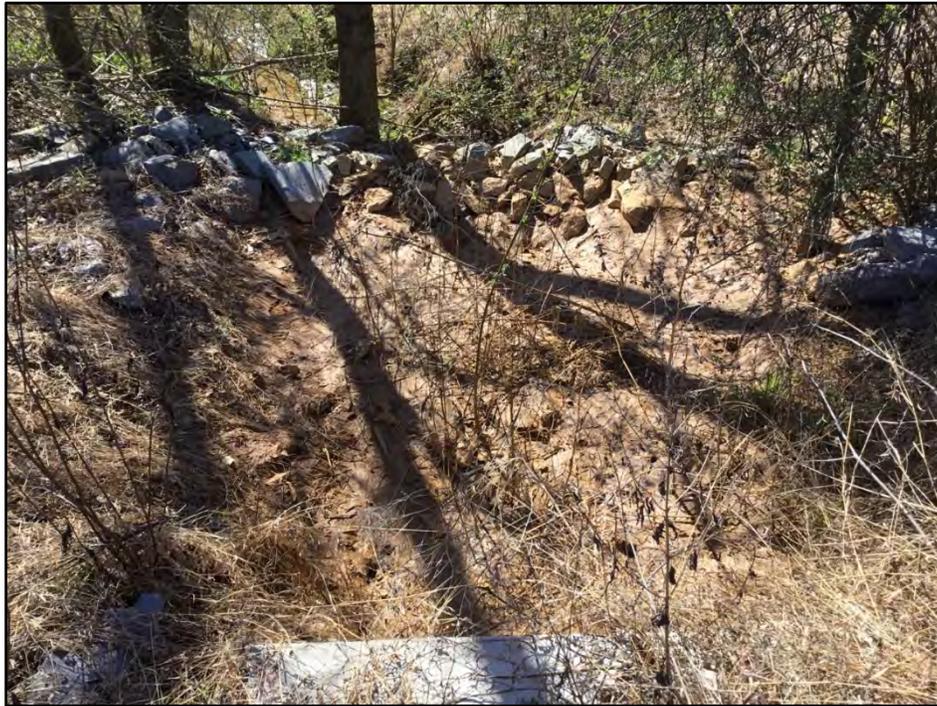
Photo 20 - View of Sedimentation at a Pipe Outfall near the Stream

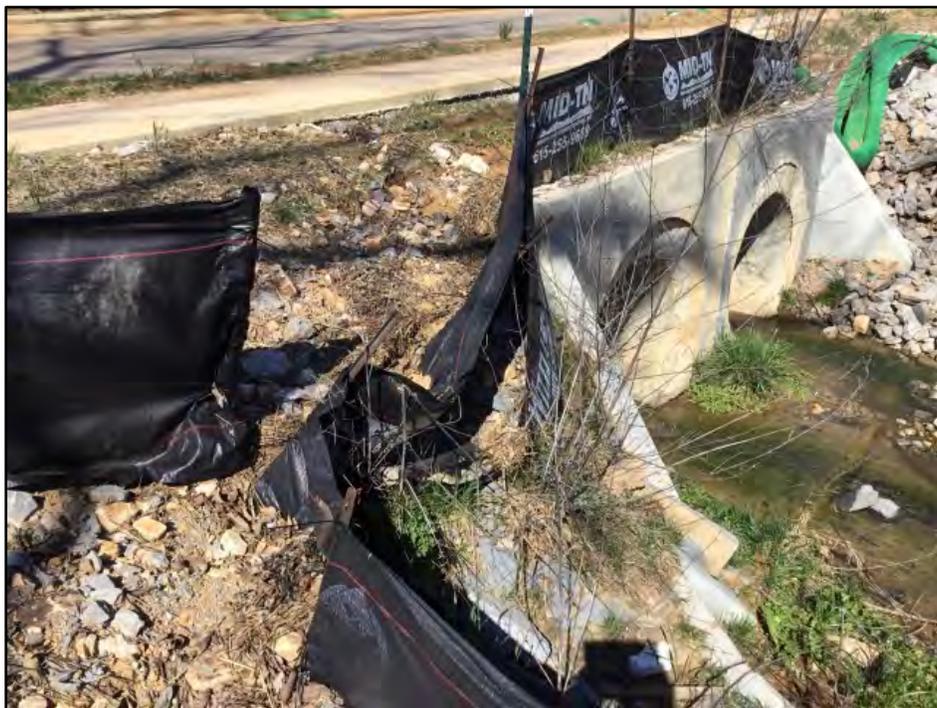
Photo 21 - View of Inadequately Maintained Erosion Control Measures

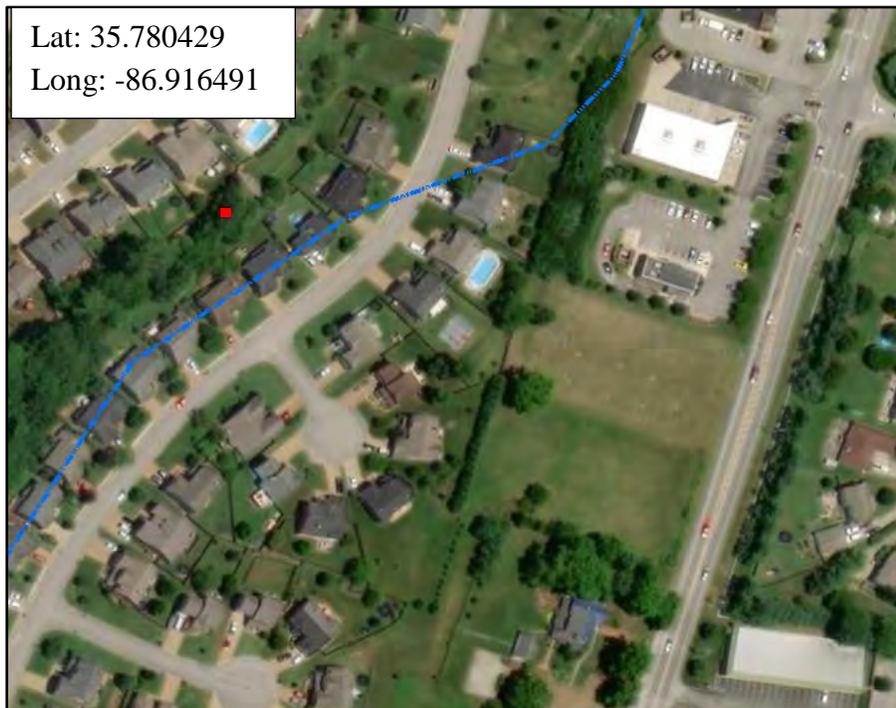
CEC personnel noted a channel alteration to the stream in the form of a berm with a reinforced concrete pipe (RCP) and rip rap. The outlet end of the RCP is sloughing above the headwall and rip rap has migrated downstream. The channel alteration appears to be causing streambank erosion downstream. This point is a “Channel Alteration” point (Object ID 12) in the geodatabase provided. Refer to Figure 3.

*Photo 22 - Aerial View of the Channel Alteration
(Red Square Indicates Alteration Location)*

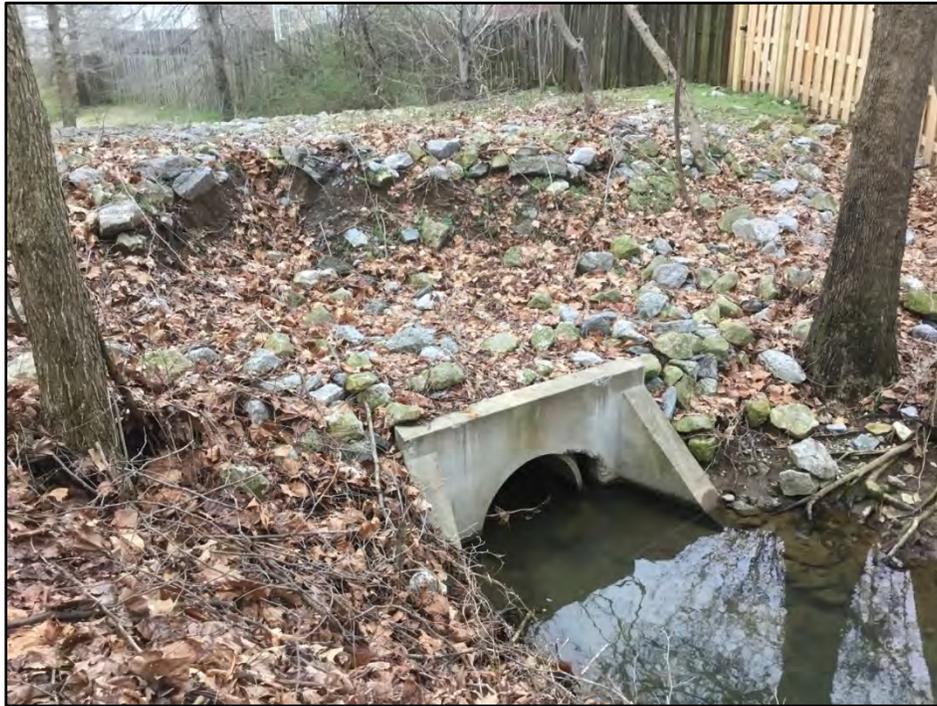
Photo 23 - View of Channel Alteration (Object ID 12)

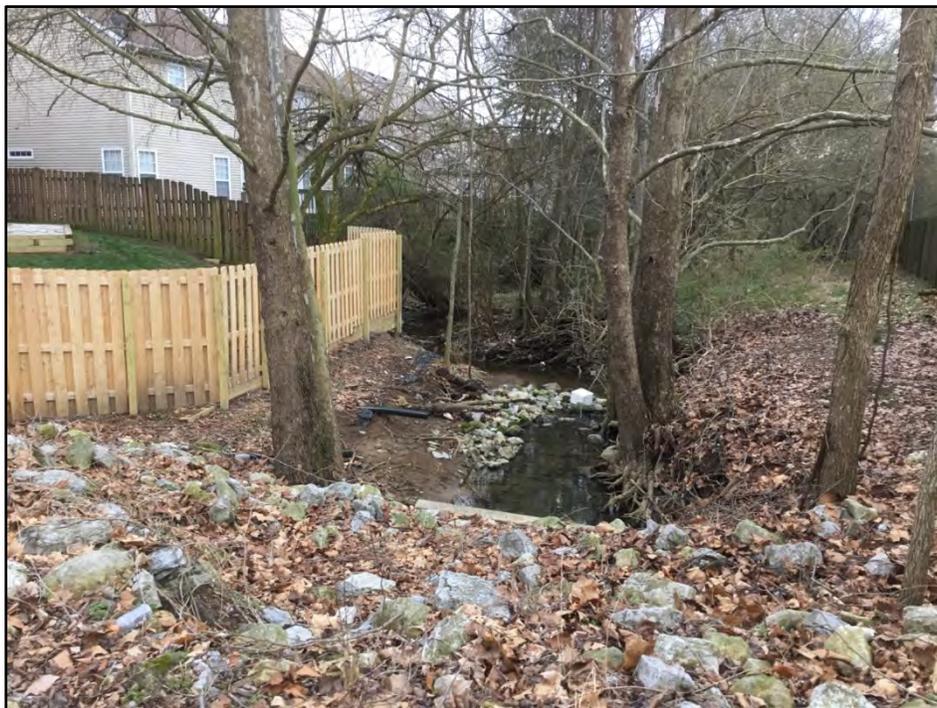
Photo 24 - View of Erosion Downstream of Channel Alteration (Object ID 12)

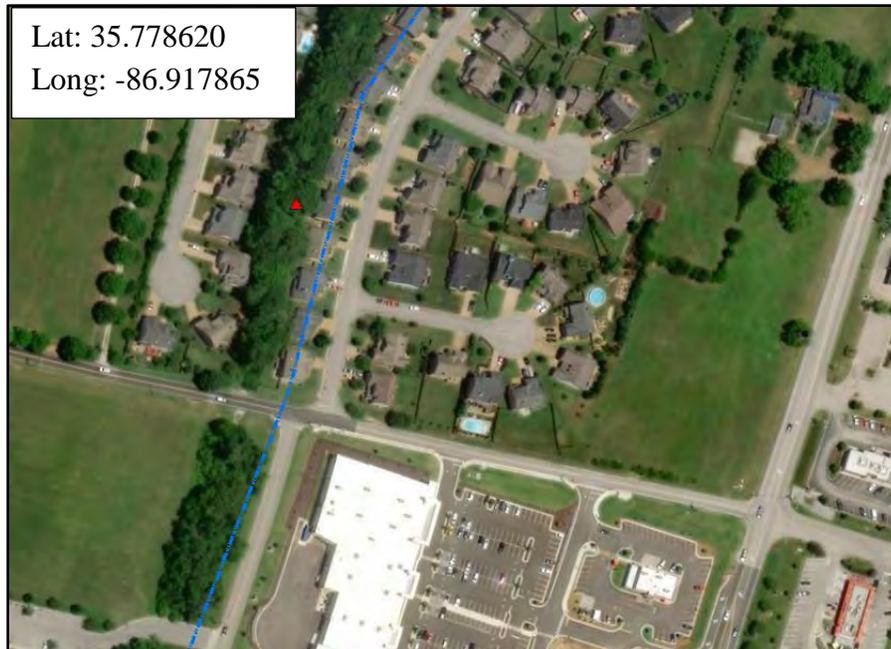
Streambank erosion was noted downstream of the previously mentioned channel alteration. The erosion site is approximately 100 LF on both the right and left streambanks with an average exposed bank height of six feet. This point is an “Erosion Site” point (Object ID 8) in the geodatabase provided. Refer to Figure 3.

*Photo 25 - Aerial View of the Erosion Site
(Red Triangle Indicates Erosion Location)*

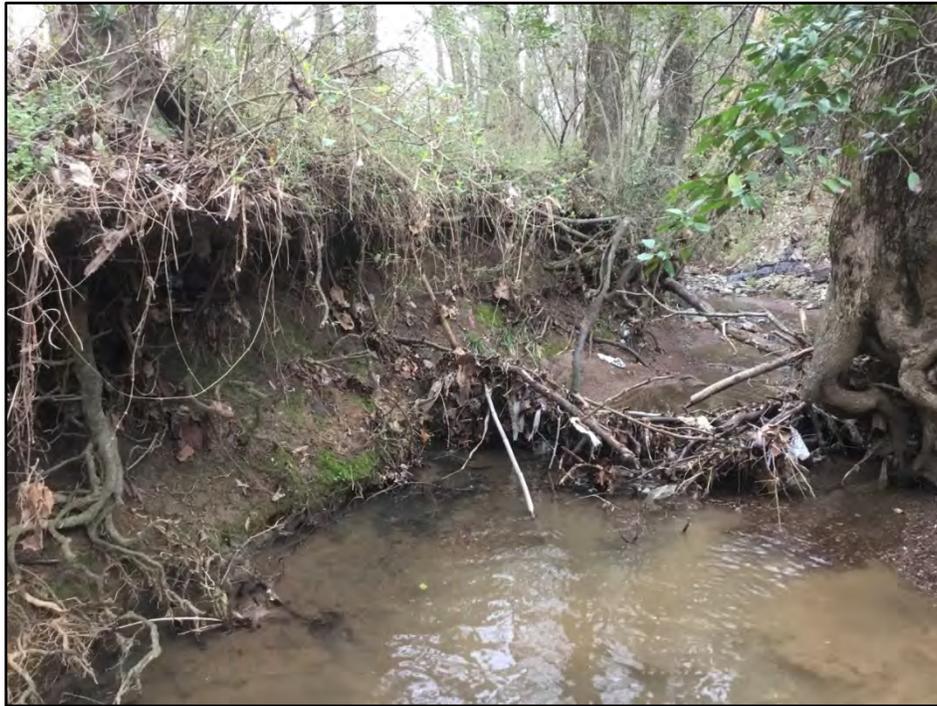
Photo 26 - View of the Erosion Site (Object ID 8)

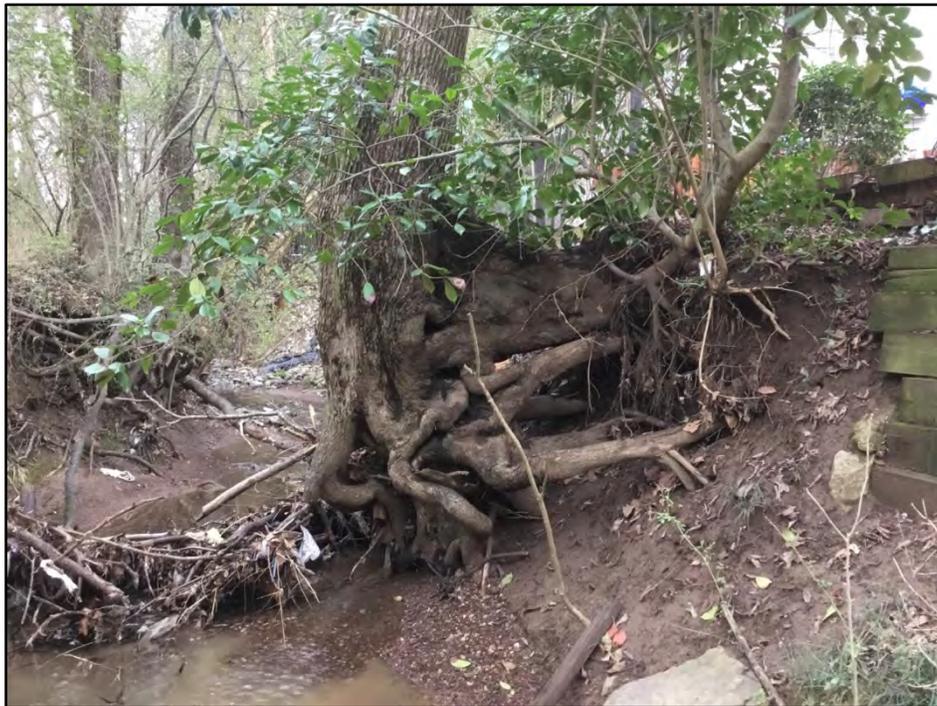
Photo 27 - View Downstream of the Erosion Site (Object ID 8)

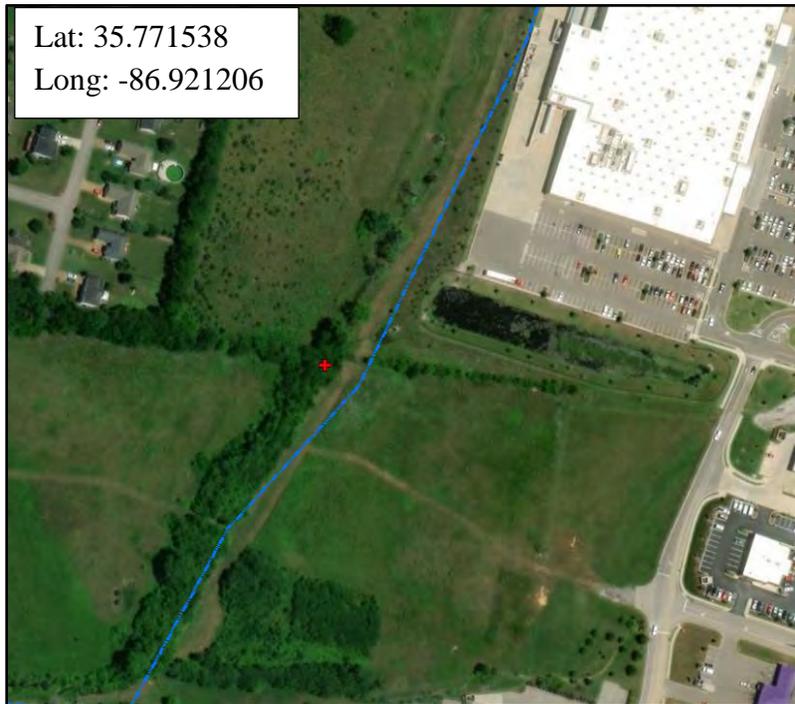
CEC personnel noted a fish barrier comprised of natural debris. The debris dam has resulted in a drop of approximately two feet. This point is a “Fish Barrier” point (Object ID 9) in the geodatabase provided. Refer to Figure 3.

*Photo 28 - Aerial View of the Fish Barrier
(Red Cross Indicates Barrier Location)*

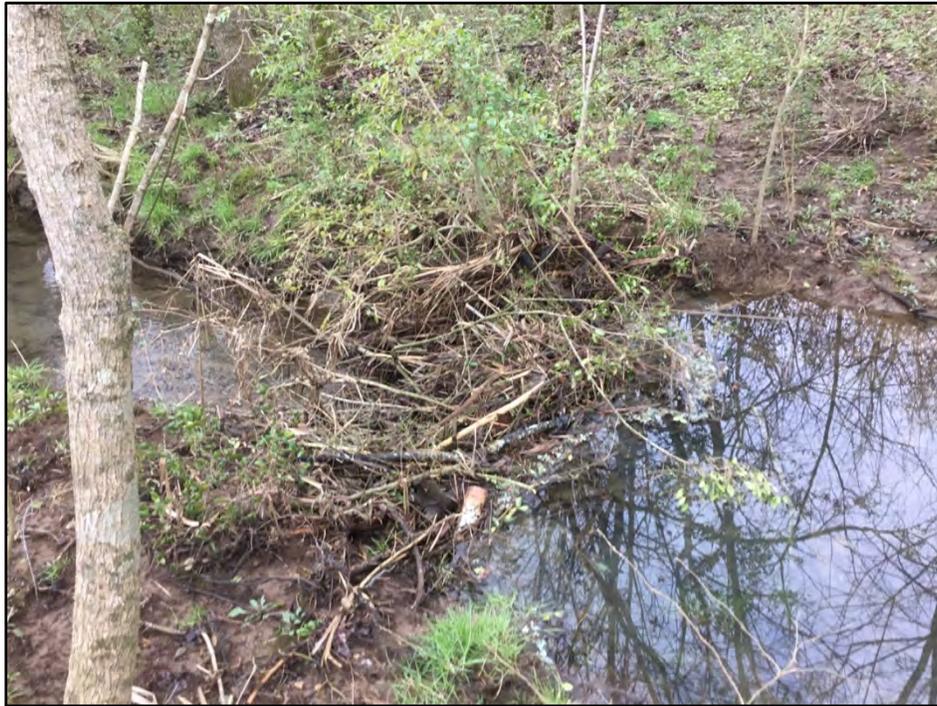
Photo 29 - View of the Fish Barrier (Object ID 9)

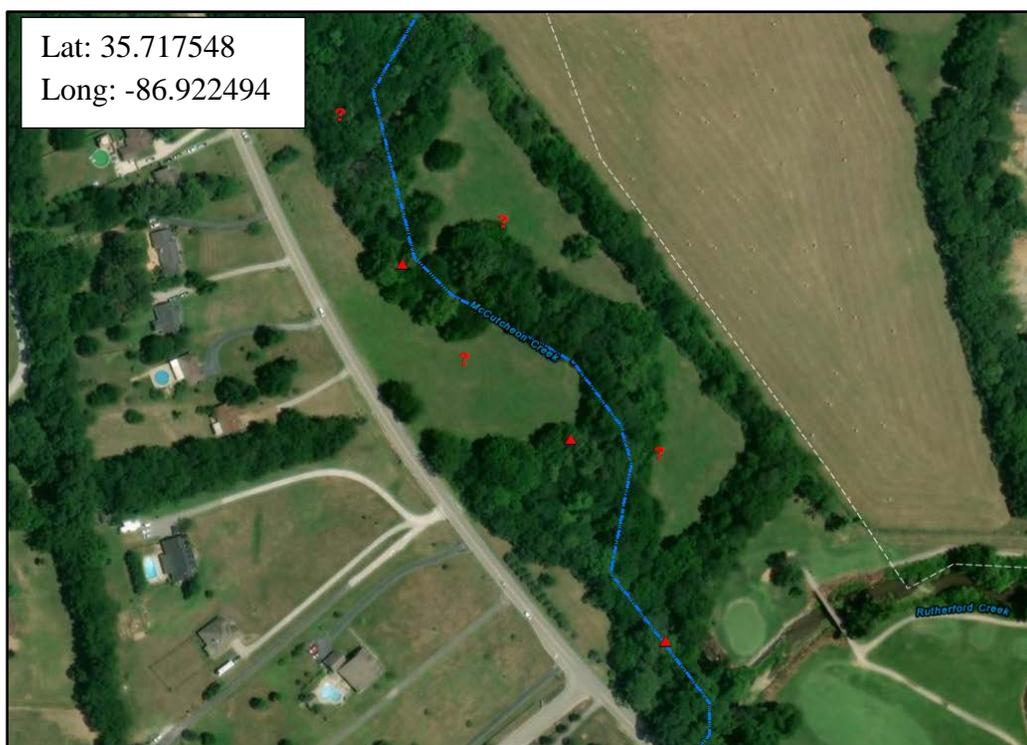
CEC personnel observed three erosion sites near Kedron Road. Each erosion site is approximately 150 LF with an average exposed bank height of 15 feet. The proximity of the erosion sites, the easy access and open, low-lying adjacent areas of this 0.25-mile stretch of McCutcheon Creek may serve as potential stream restoration and/or wetland mitigation sites. These points are “Erosion Site” points (Object ID 23, 24 and 25) and “Unusual Condition or Comment” (Object ID 97, 98 and 99) in the geodatabase provided. Refer to Figure 4.

*Photo 30 - Aerial View of Erosion Sites and Potential Mitigation Sites
(Red Triangles Indicate Erosion Locations and Red Question Marks Indicate Potential
Wetland Mitigation Sites)*

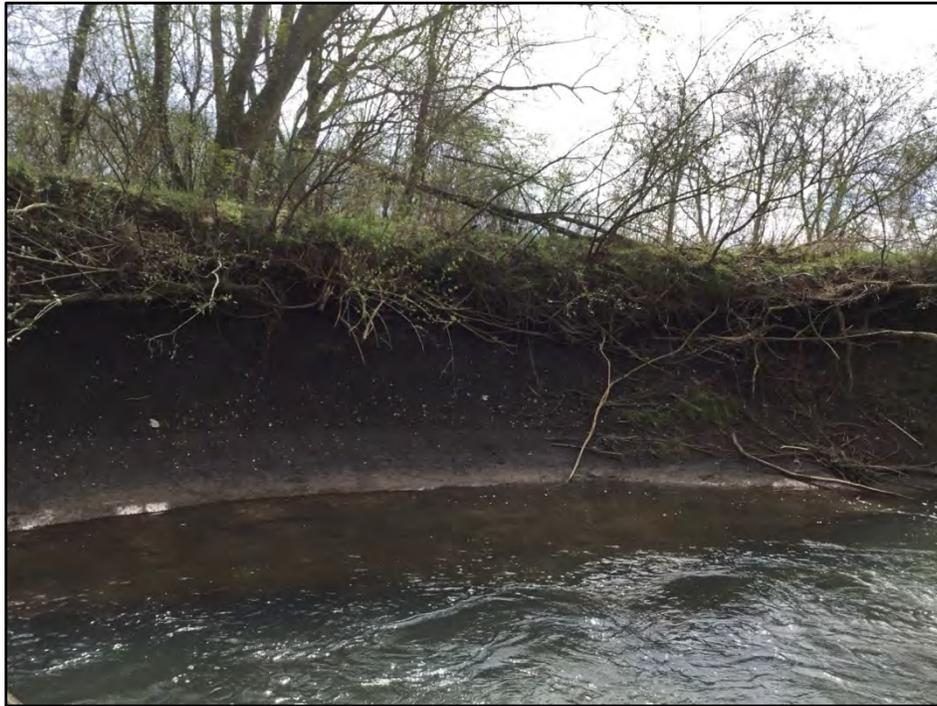
Photo 31 - View of Streambank Erosion

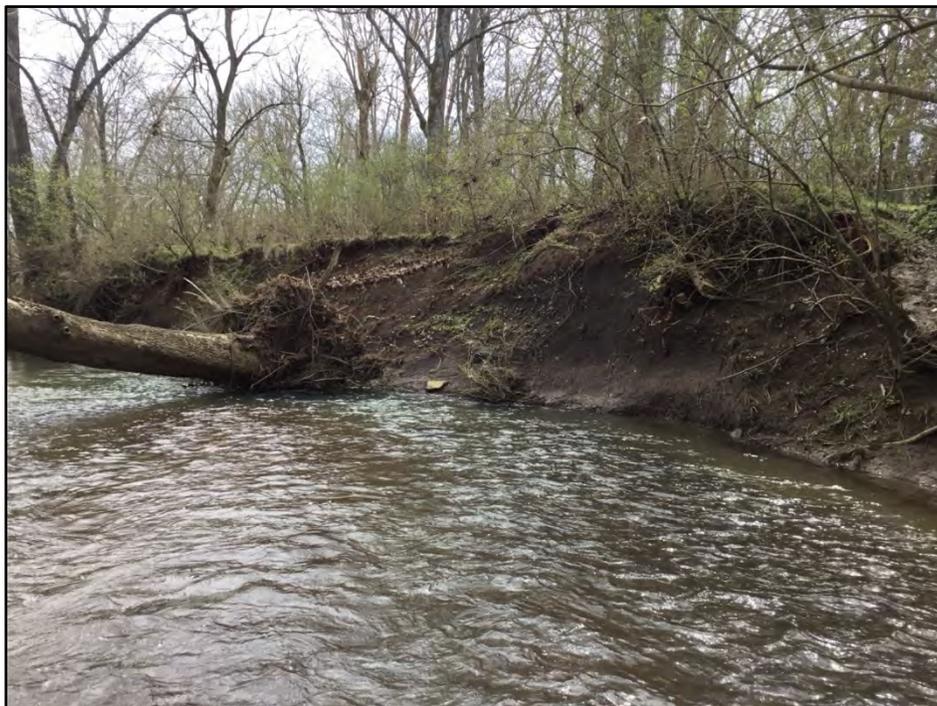
Photo 32 - View of Streambank Erosion

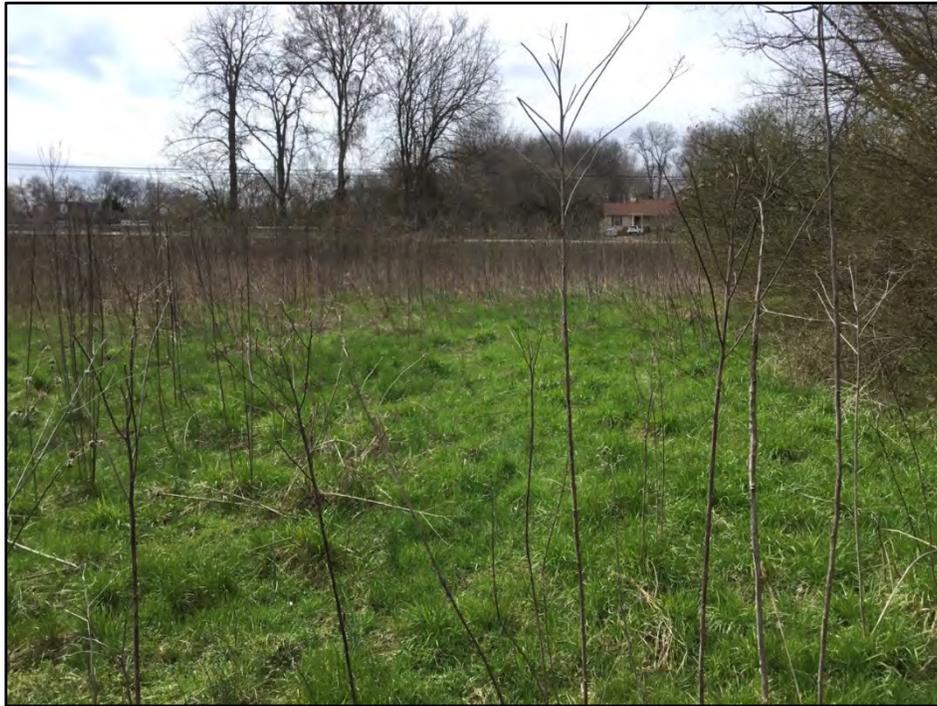
Photo 33 - View of Low-lying Area Adjacent to the Stream
