May 20, 2020

Subject: 2020 Visual Stream Assessment (VSA)
MS4 Permit – Non-Analytical Stream Monitoring
City of Spring Hill, Maury and Williamson Counties, Tennessee
CEC Project 194-523.0001

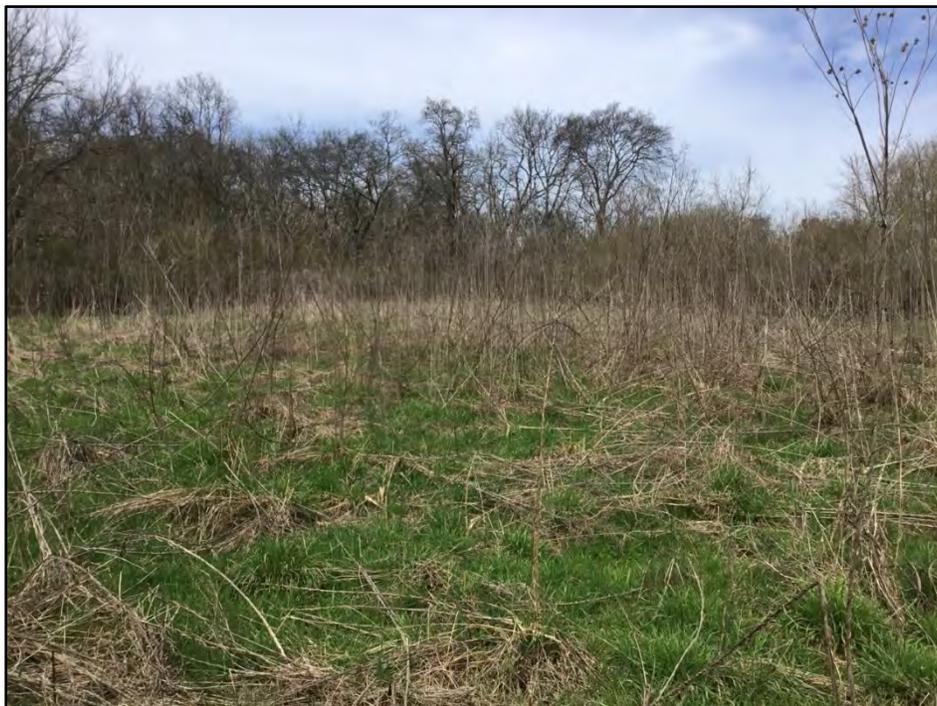
Photo 34 - View of a Low-lying Area Adjacent to the Stream

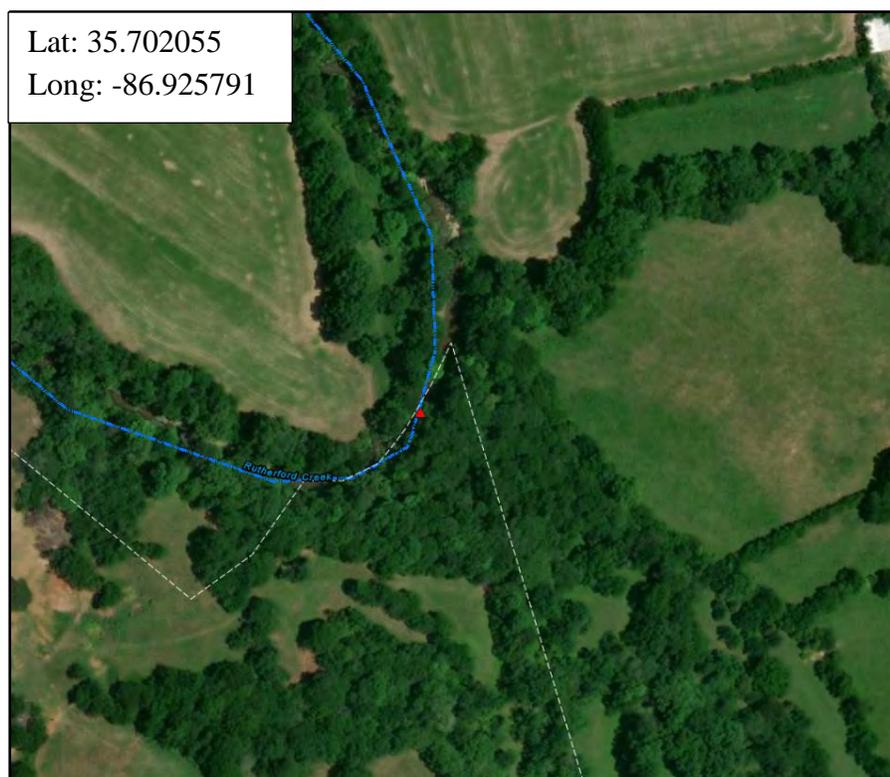
An erosion site of approximately 800 LF was noted on the left streambank. The average exposed bank height was 10 feet. Recent clearing activities were evident. CEC wants to bring the erosion site to the attention of the City as it appears that additional clearing and/or construction activities may be planned. This point is an “Erosion Site” point (Object ID 6) in the geodatabase provided. Refer to Figure 5.

*Photo 35 - Aerial View of Erosion Site
(Red Triangle Indicates Erosion Location)*

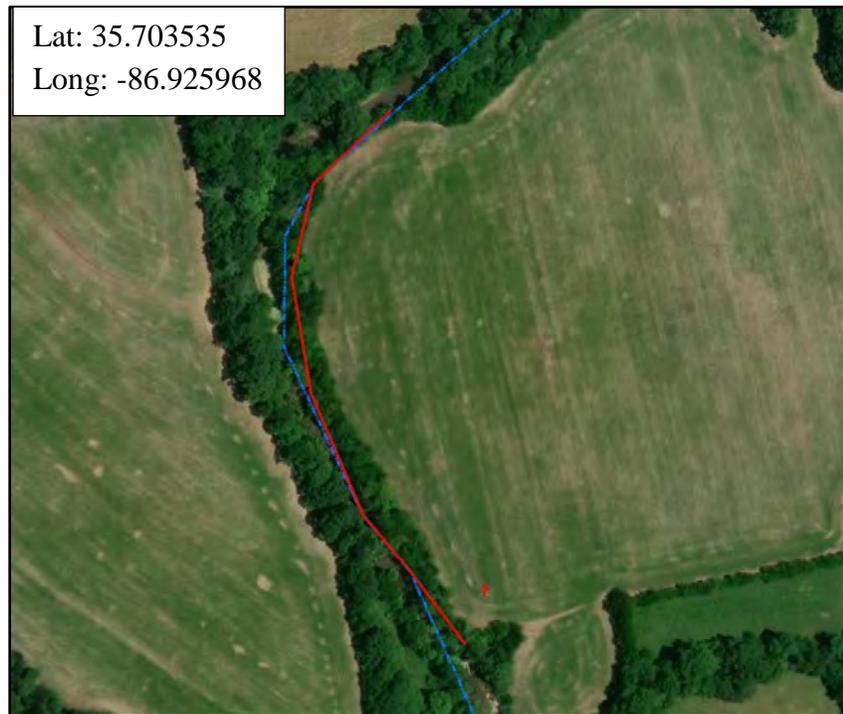
An inadequate buffer of approximately 1274 LF was observed by field personnel. The average buffer width on the left streambank was approximately 15 feet. An adjacent low-lying area along the narrow tree line was also observed. This location could be a potential wetland mitigation site. CEC wants to bring the inadequate buffer to the attention of the City as it appeared during the field survey that construction activities may be planned near this area. This point is an “Inadequate Buffer” point (Object ID 9) and an “Unusual Condition or Comment” (Object ID 29) point in the geodatabase provided. Refer to Figure 5.

*Photo 37 - Aerial View of Inadequate Buffer
(Red Line Indicates Inadequate Buffer Location and Red Question Mark indicates
Potential Wetland Mitigation Area)*

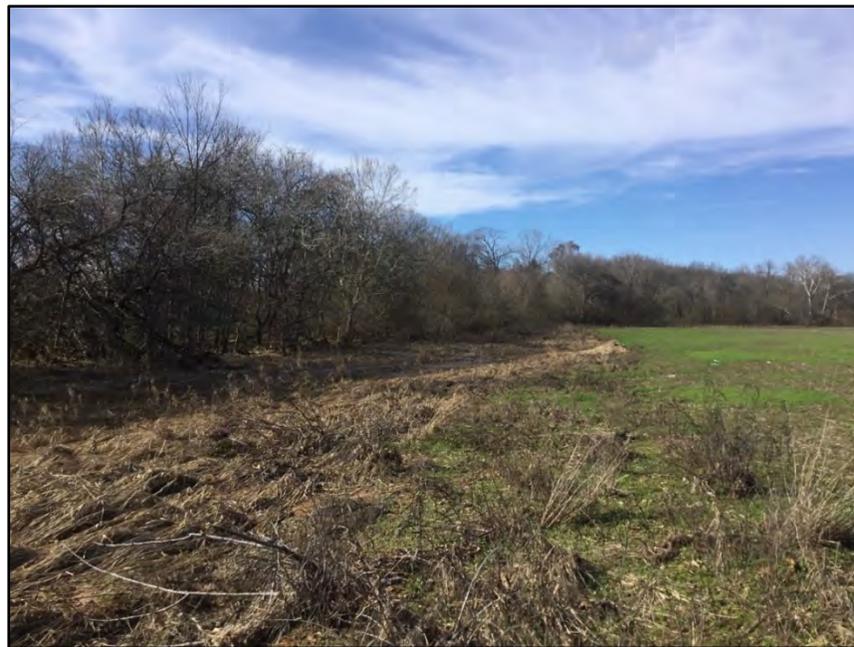
Photo 38 - View of the Inadequate Buffer and Adjacent Low-lying Area
