May 20, 2020

Subject: 2020 Visual Stream Assessment (VSA)
MS4 Permit – Non-Analytical Stream Monitoring
City of Spring Hill, Maury and Williamson Counties, Tennessee
CEC Project 194-523.0001

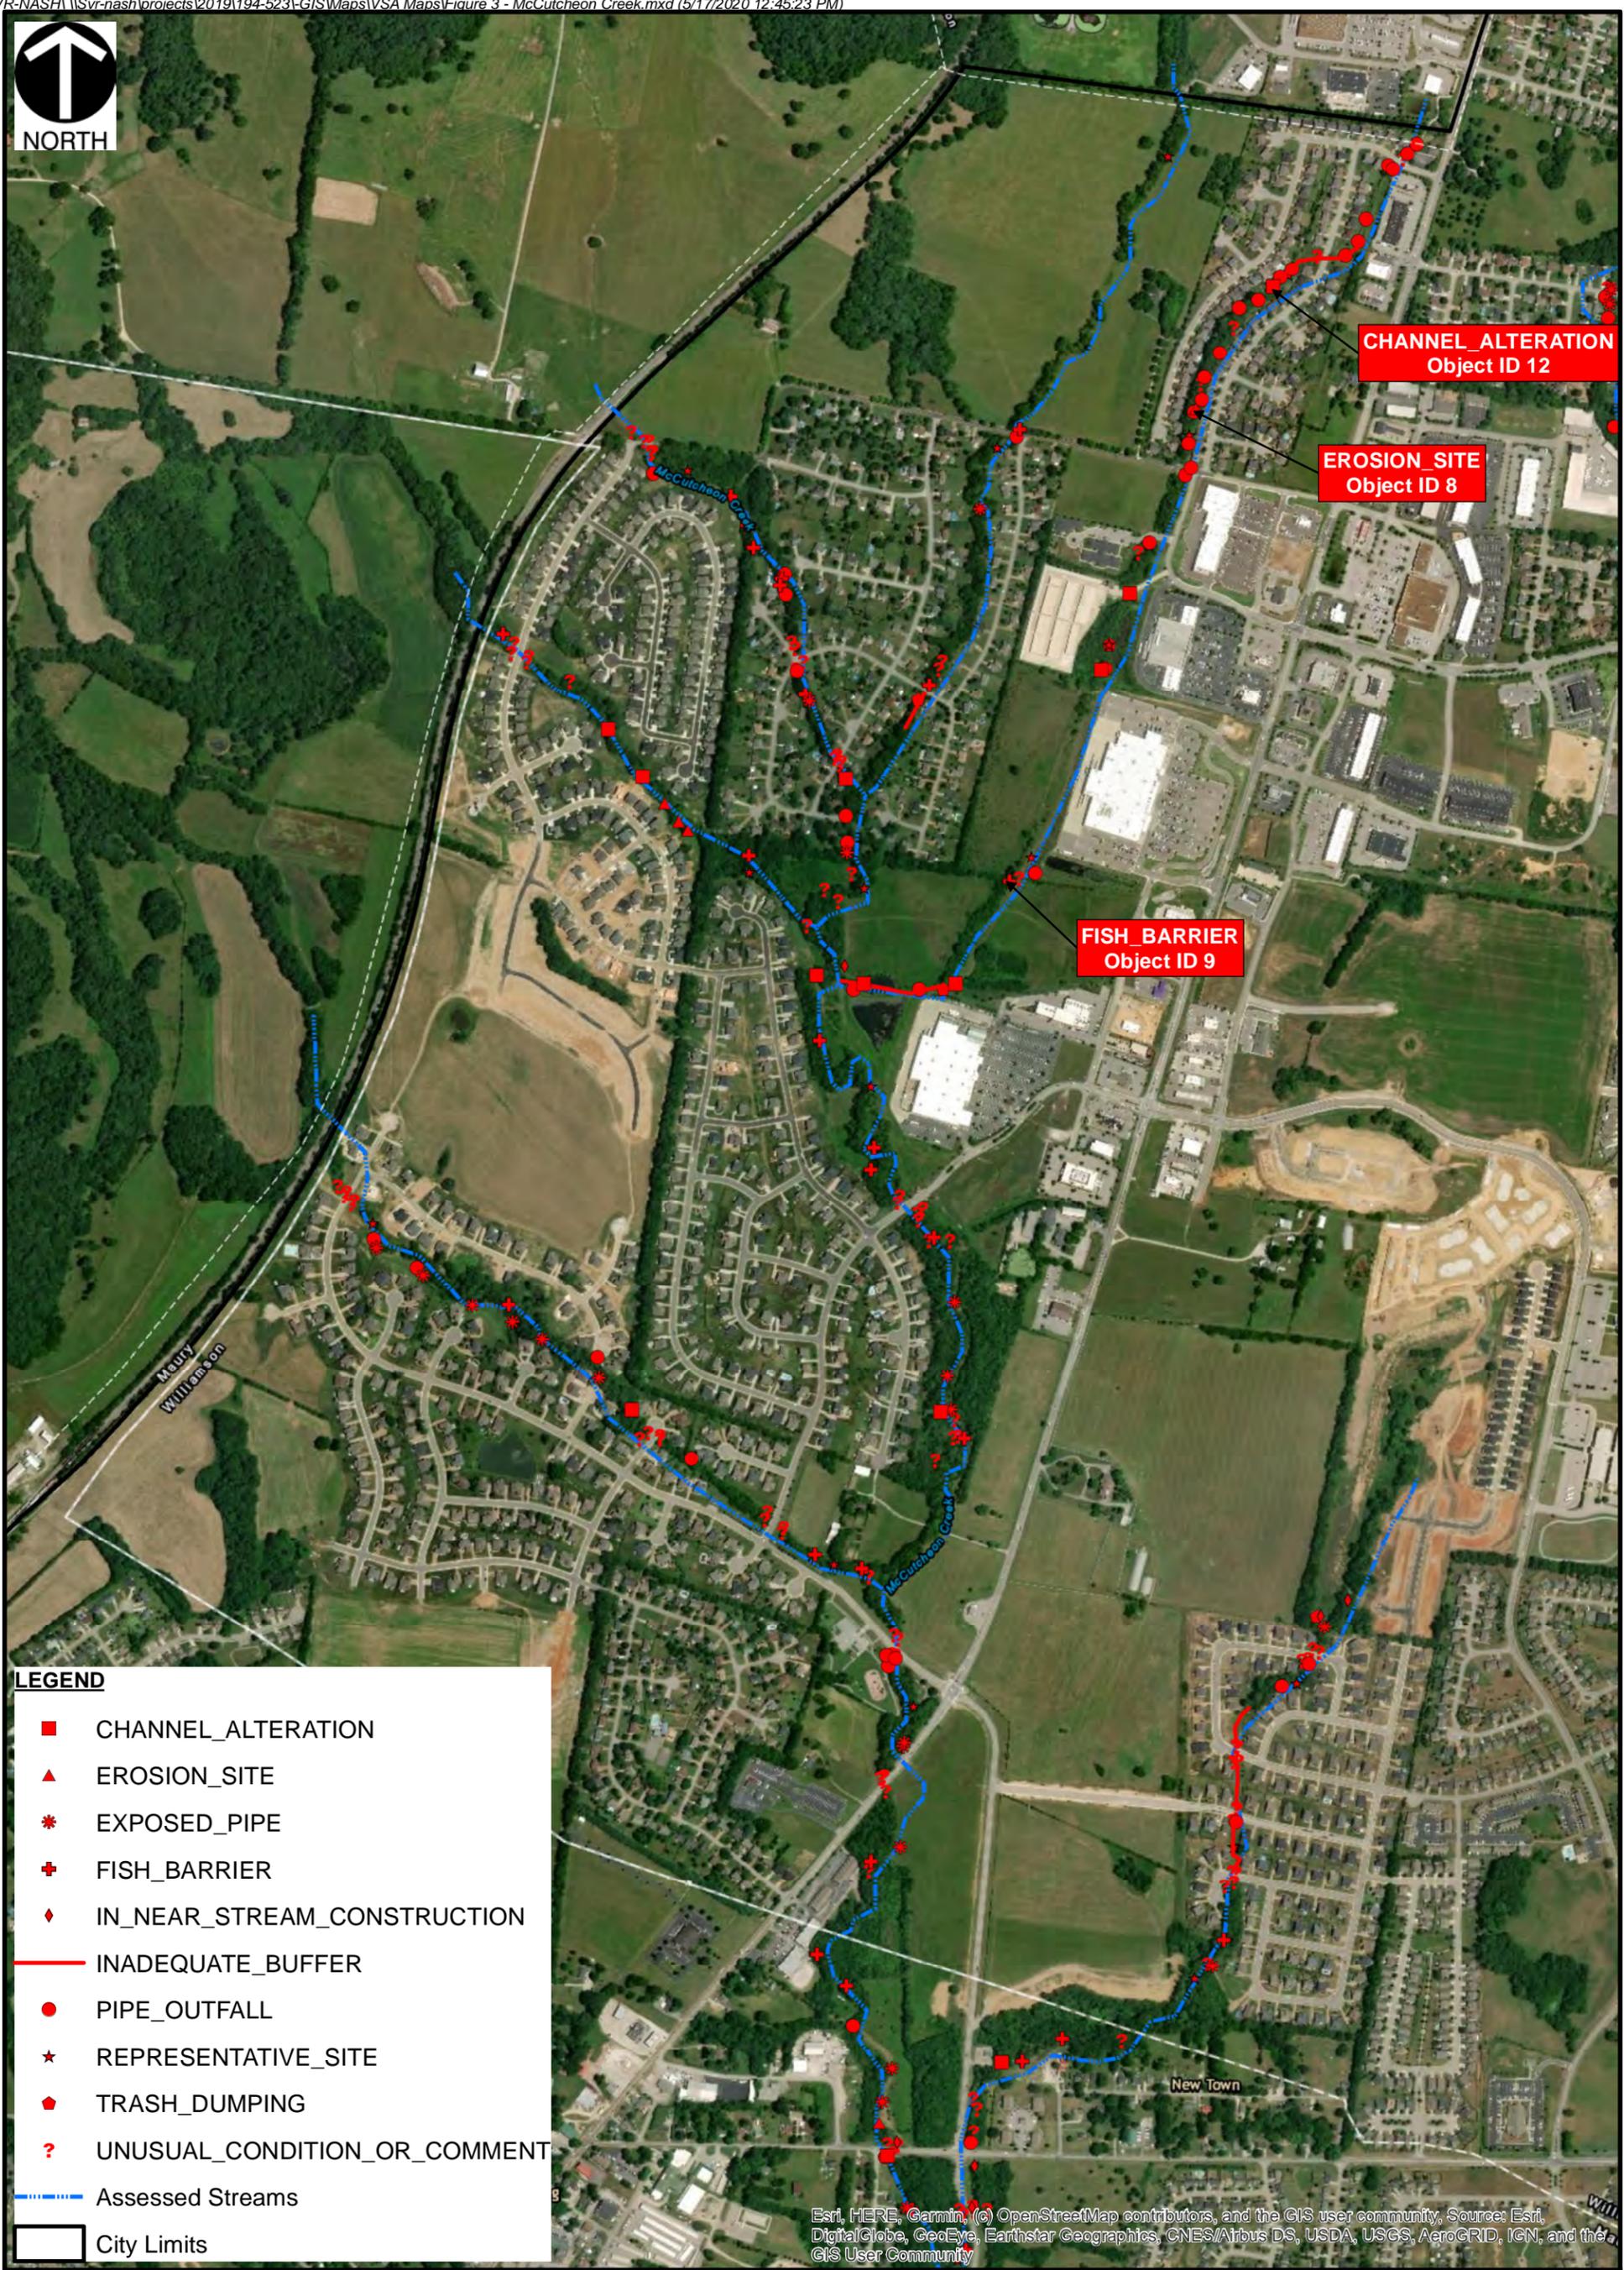
Streambank erosion was noted downstream of the previously mentioned channel alteration. The erosion site is approximately 100 LF on both the right and left streambanks with an average exposed bank height of six feet. This point is an “Erosion Site” point (Object ID 8) in the geodatabase provided. Refer to Figure 3.

CEC personnel noted a fish barrier comprised of natural debris. The debris dam has resulted in a drop of approximately two feet. This point is a “Fish Barrier” point (Object ID 9) in the geodatabase provided. Refer to Figure 3.

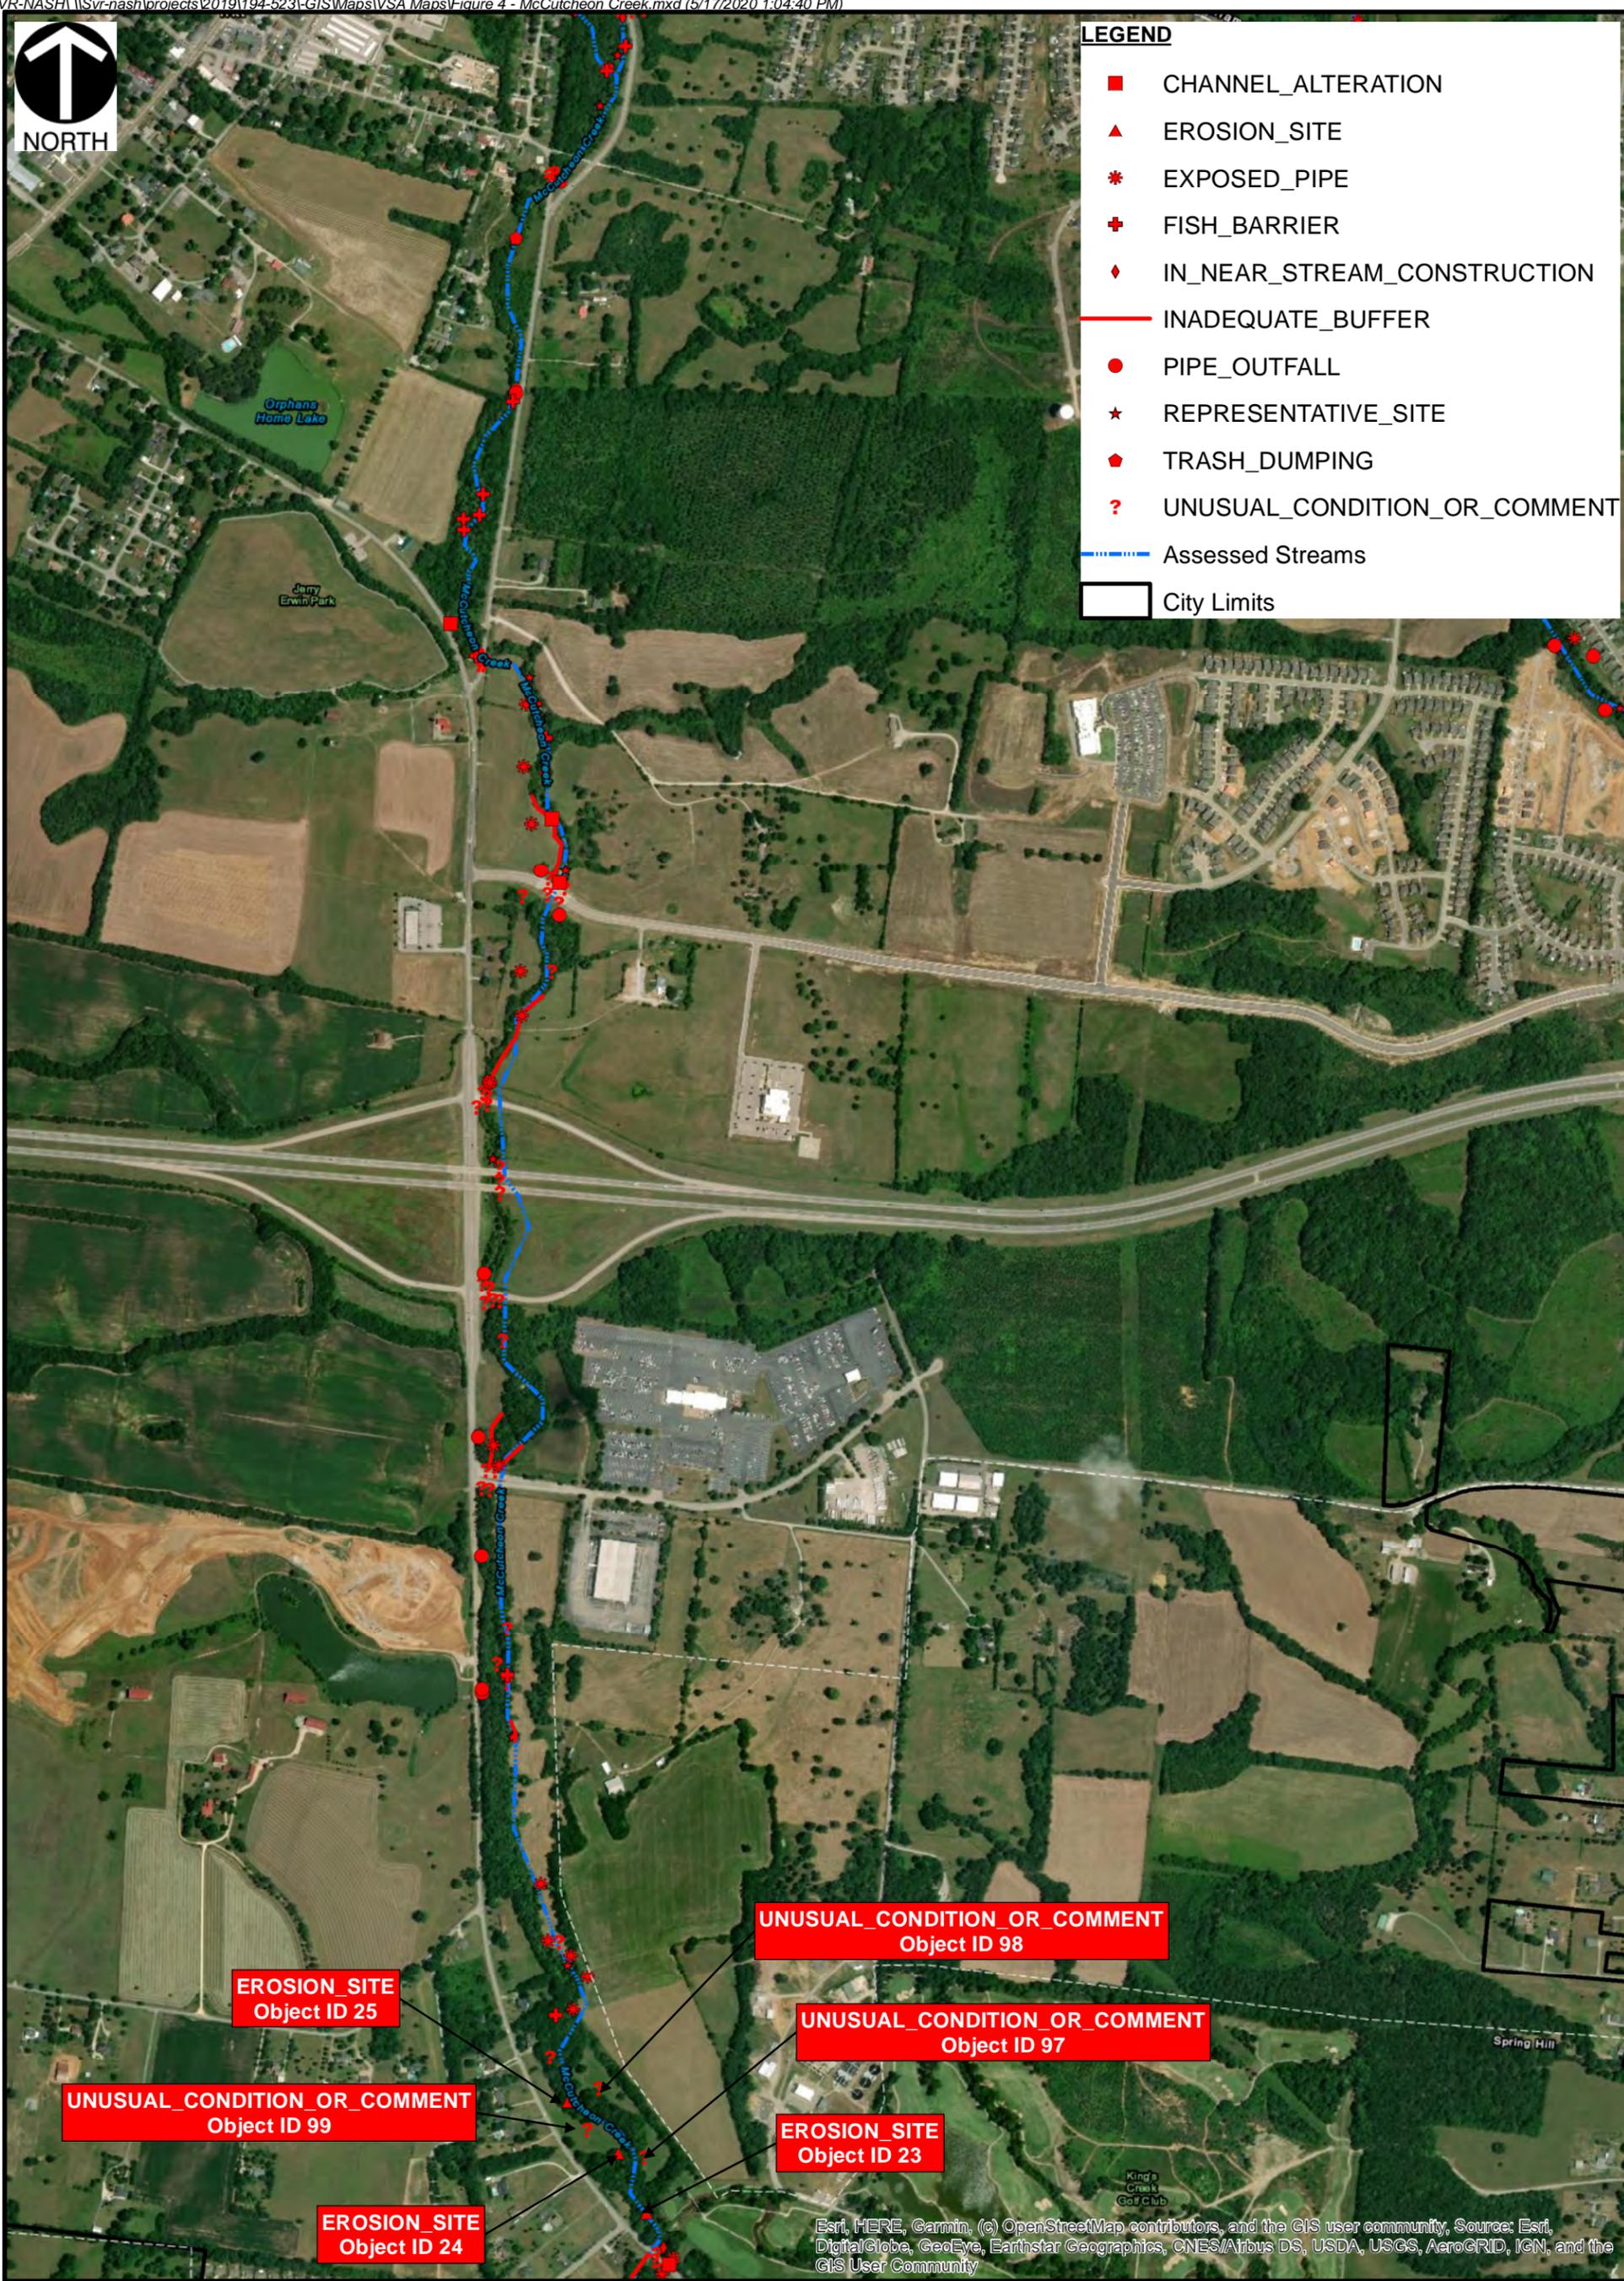
DRAWN BY:	LWK	CHECKED BY:	TJN										
DATE:	5/17/2020	SCALE:	1" = 917'										
APPROVED BY:	SEC												
PROJECT NO:	194-523.0001												
		FIGURE NO: 4

CEC personnel observed three erosion sites near Kedron Road. Each erosion site is approximately 150 LF with an average exposed bank height of 15 feet. The proximity of the erosion sites, the easy access and open, low-lying adjacent areas of this 0.25-mile stretch of McCutcheon Creek may serve as potential stream restoration and/or wetland mitigation sites. These points are “Erosion Site” points (Object ID 23, 24 and 25) and “Unusual Condition or Comment” (Object ID 97, 98 and 99) in the geodatabase provided. Refer to Figure 4.

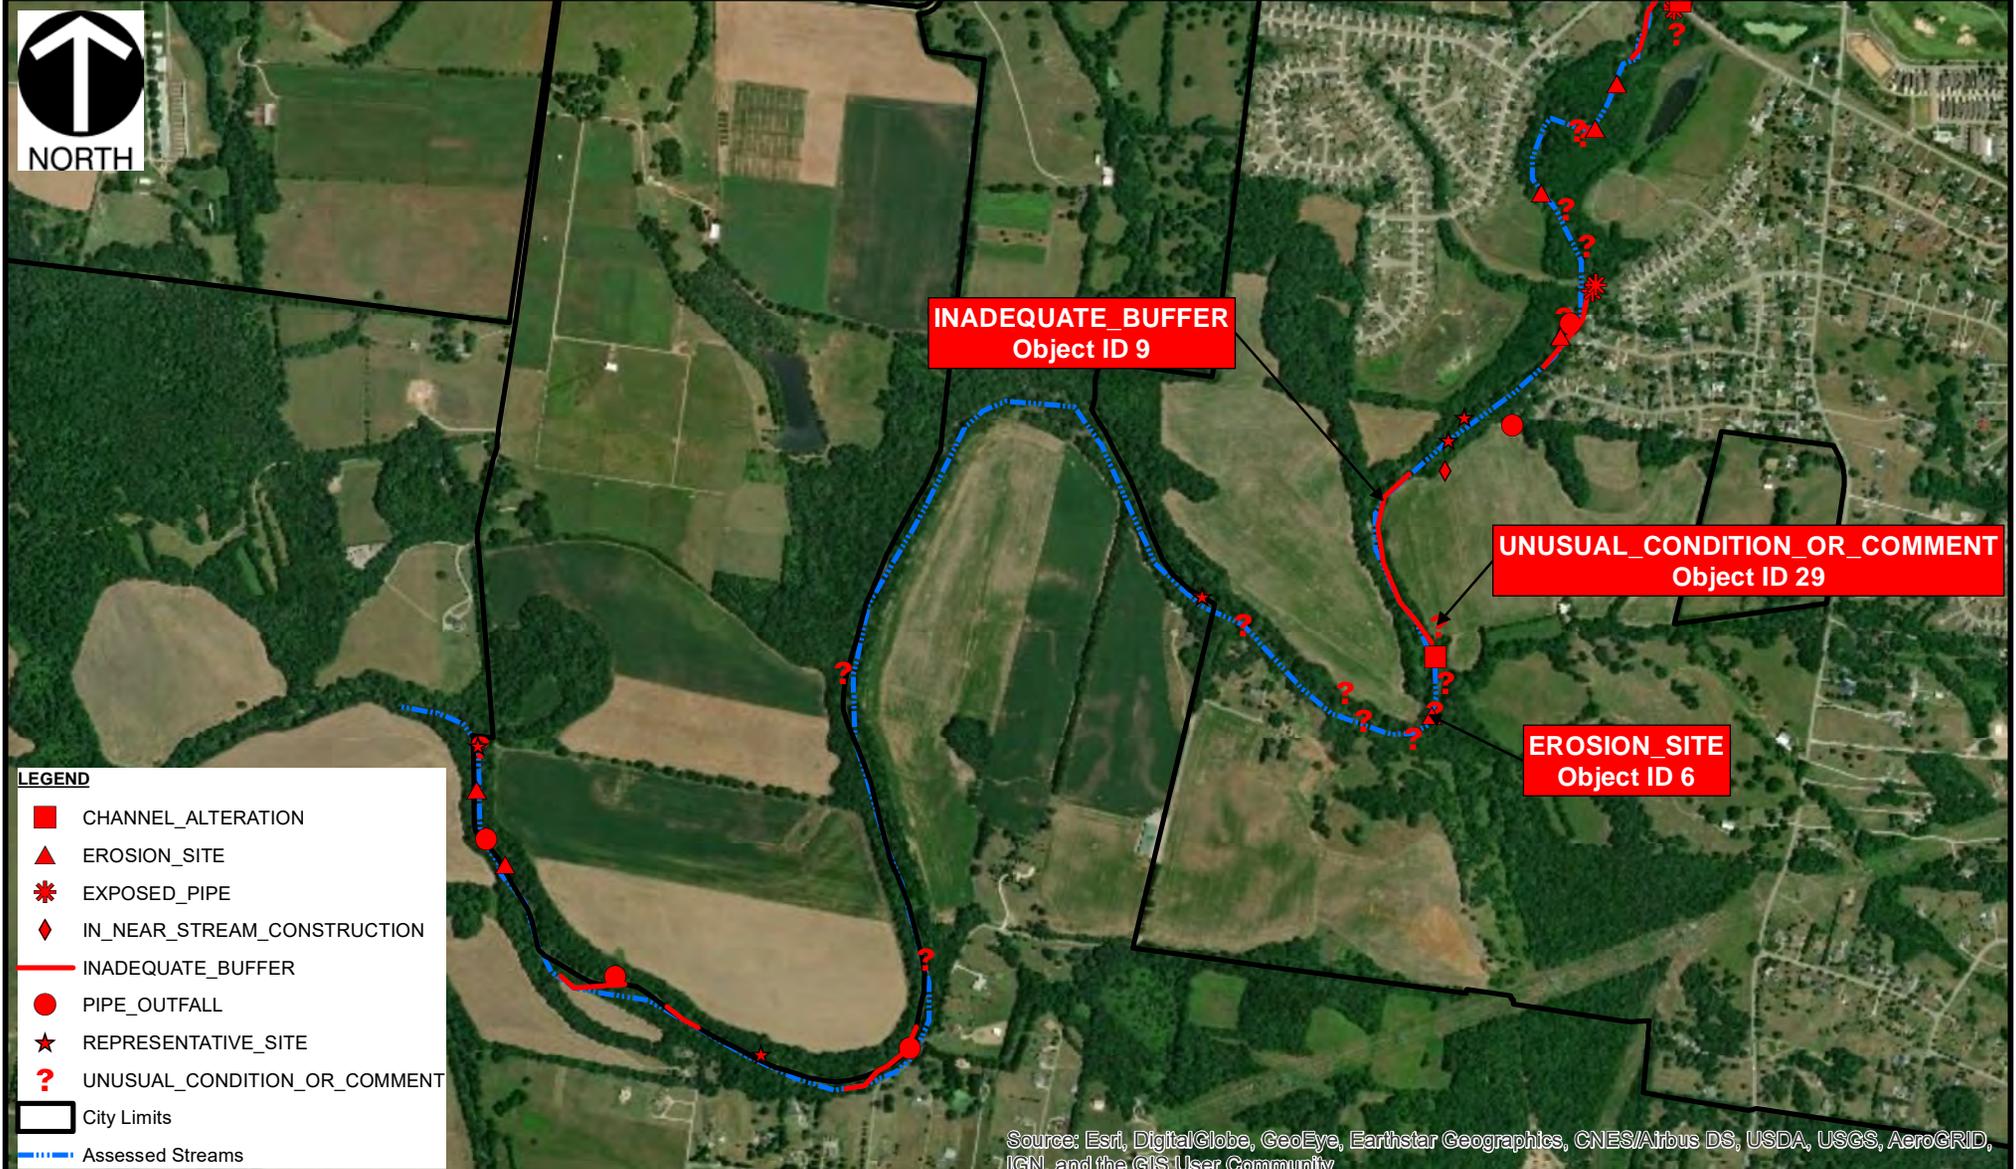
An erosion site of approximately 800 LF was noted on the left streambank. The average exposed bank height was 10 feet. Recent clearing activities were evident. CEC wants to bring the erosion site to the attention of the City as it appears that additional clearing and/or construction activities may be planned. This point is an “Erosion Site” point (Object ID 6) in the geodatabase provided. Refer to Figure 5.

An inadequate buffer of approximately 1274 LF was observed by field personnel. The average buffer width on the left streambank was approximately 15 feet. An adjacent low-lying area along the narrow tree line was also observed. This location could be a potential wetland mitigation site. CEC wants to bring the inadequate buffer to the attention of the City as it appeared during the field survey that construction activities may be planned near this area. This point is an “Inadequate Buffer” point (Object ID 9) and an “Unusual Condition or Comment” (Object ID 29) point in the geodatabase provided. Refer to Figure 5.
